# Ed Croskey Rec Center

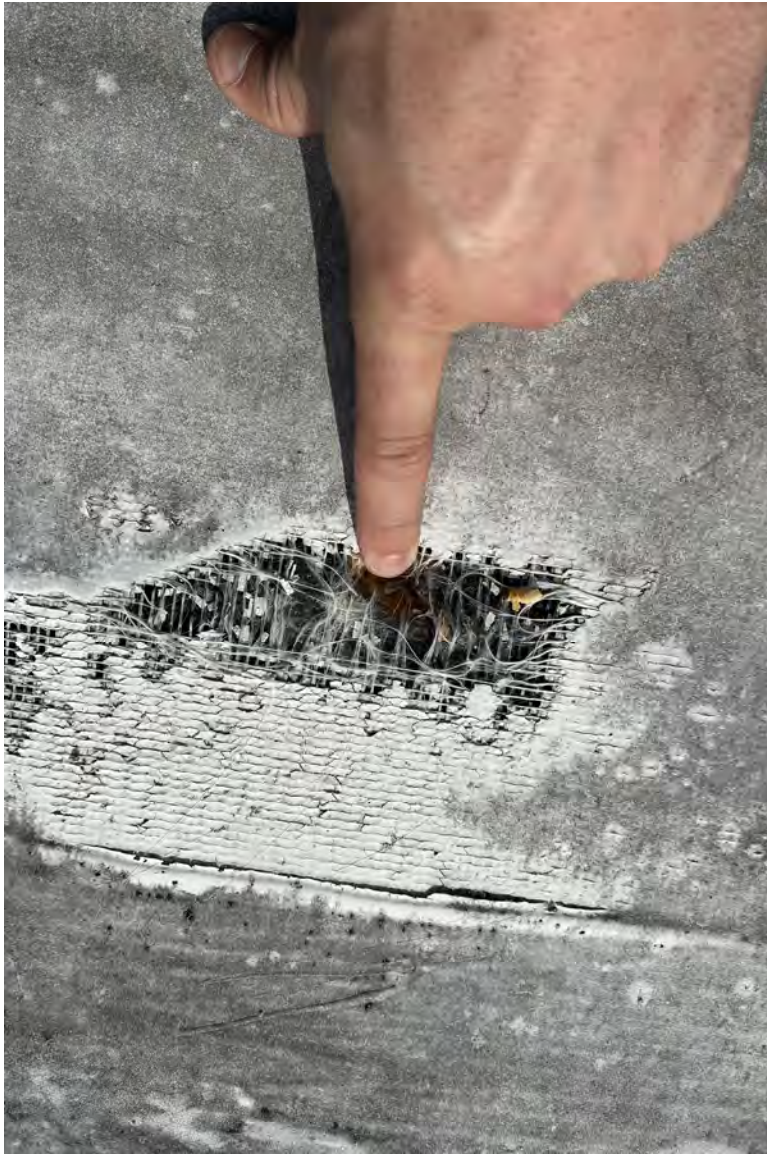
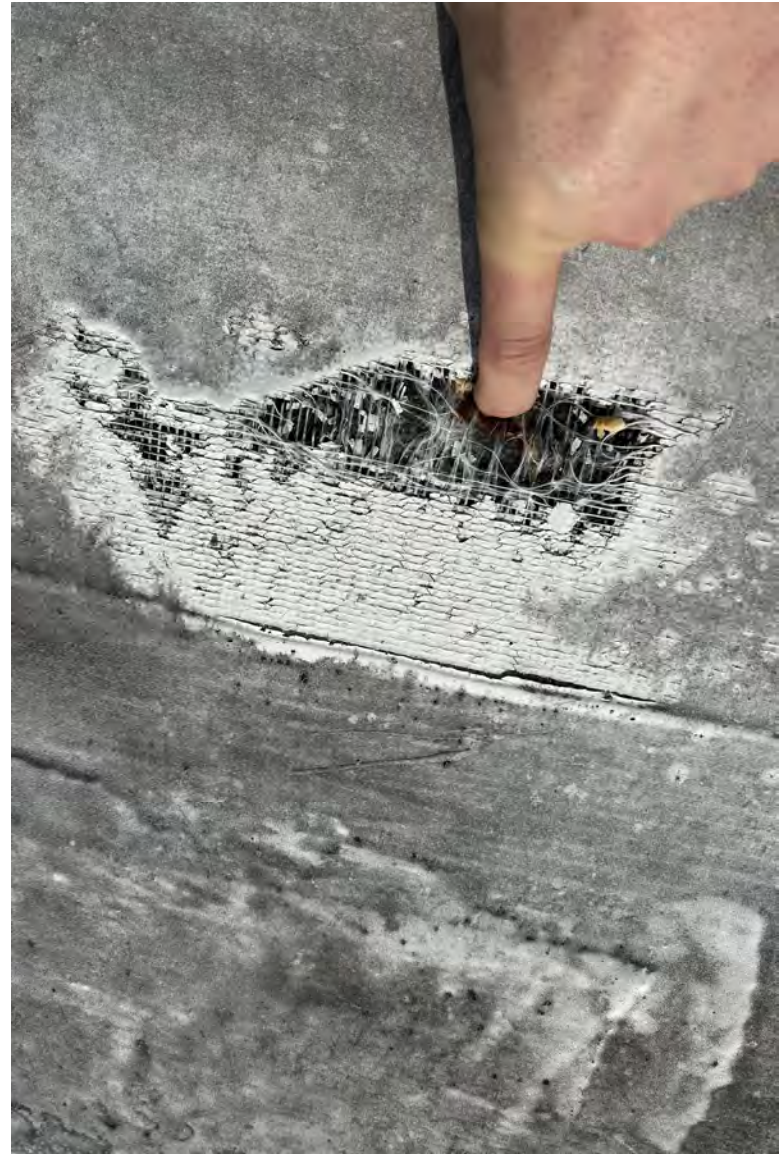
Split in Membrane

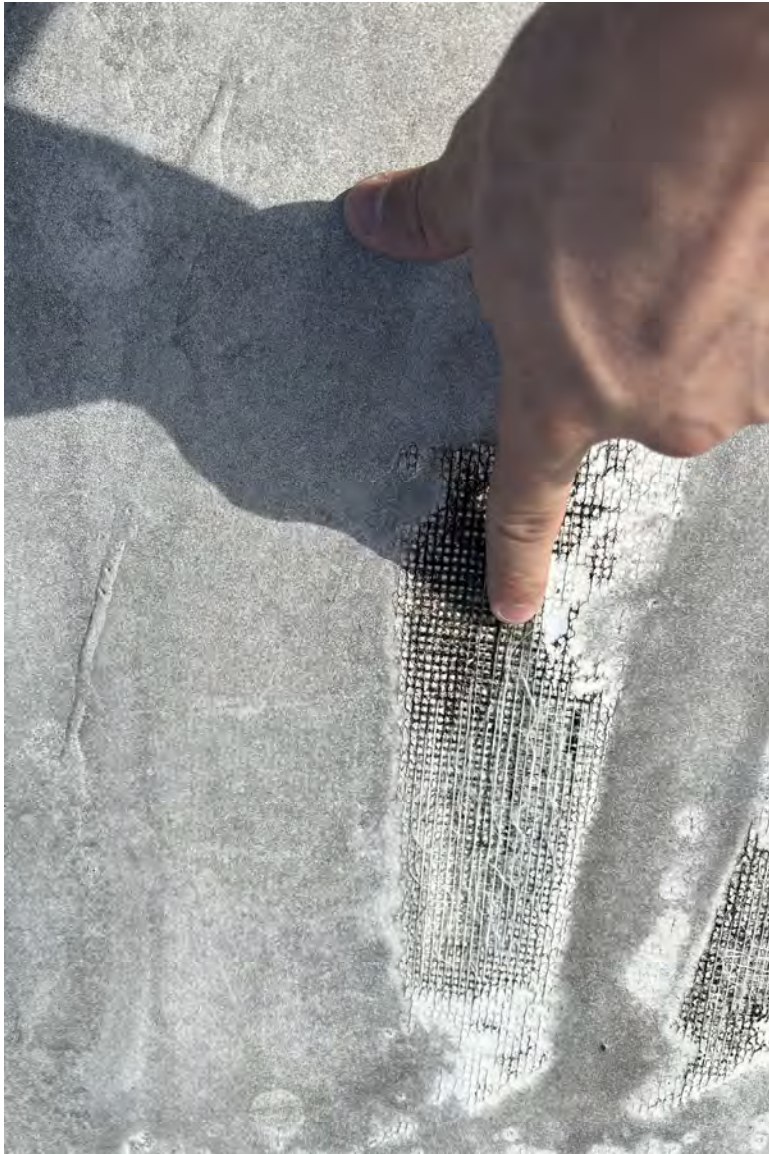
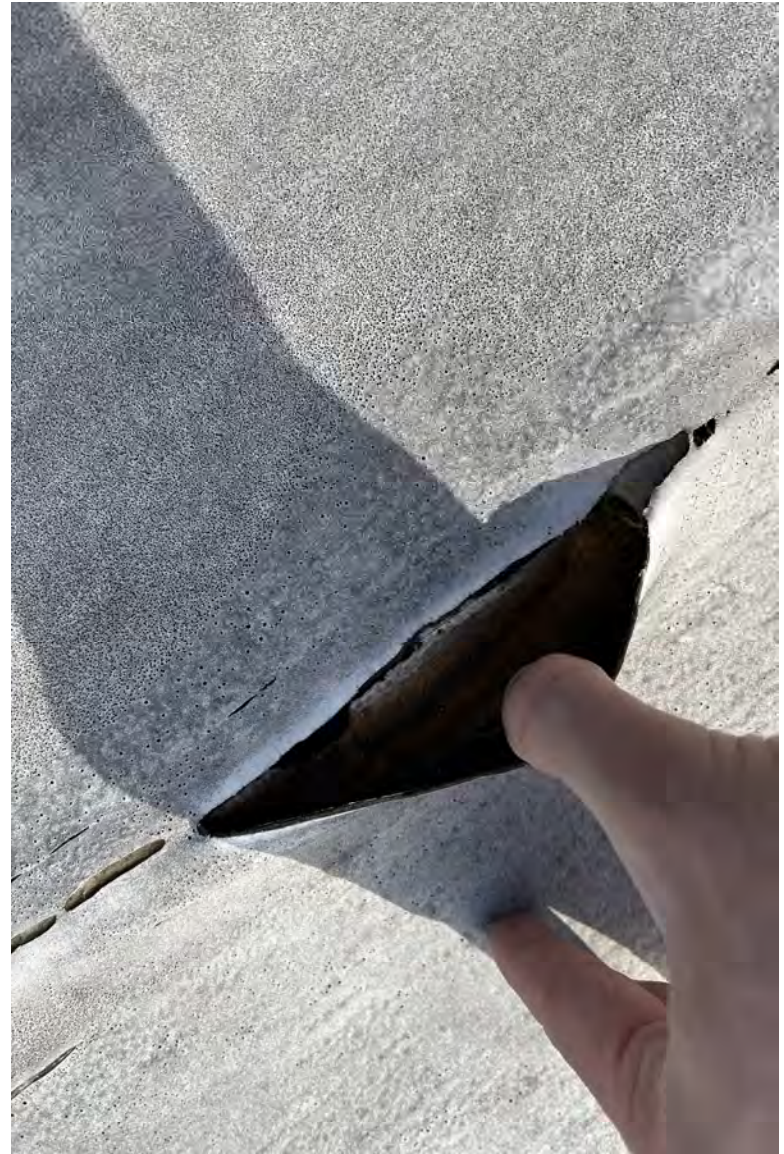
Hole in Membrane

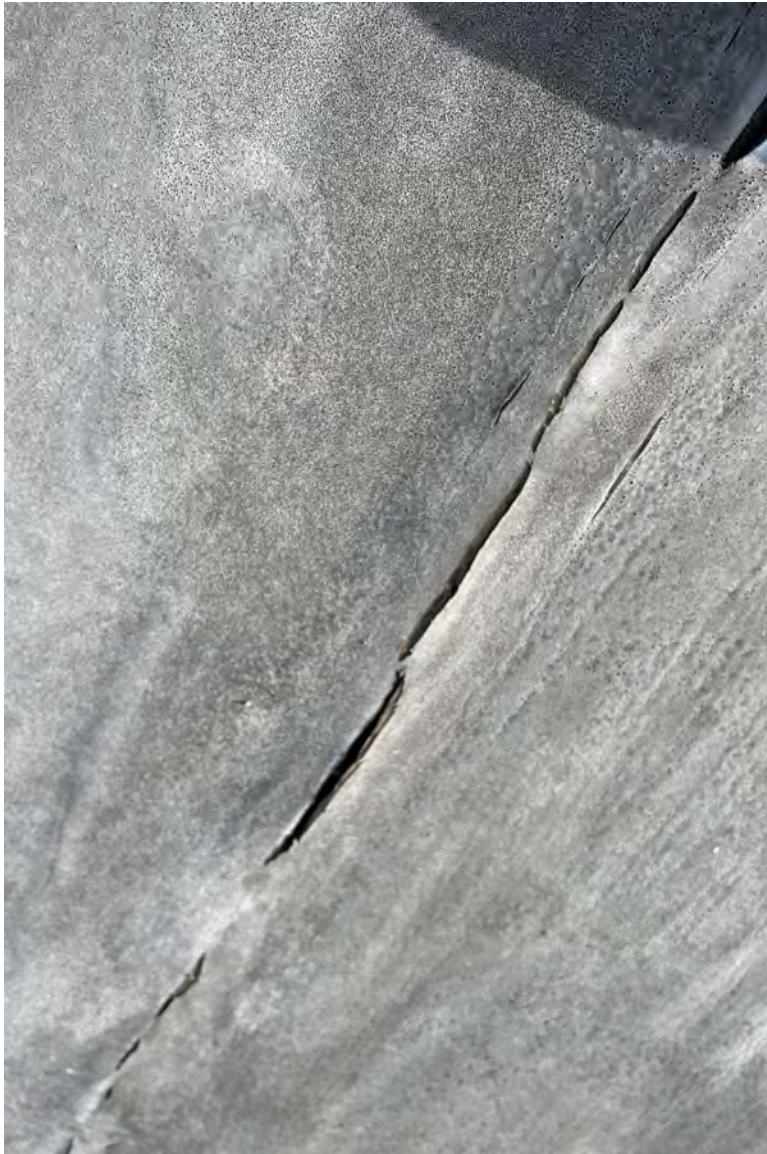
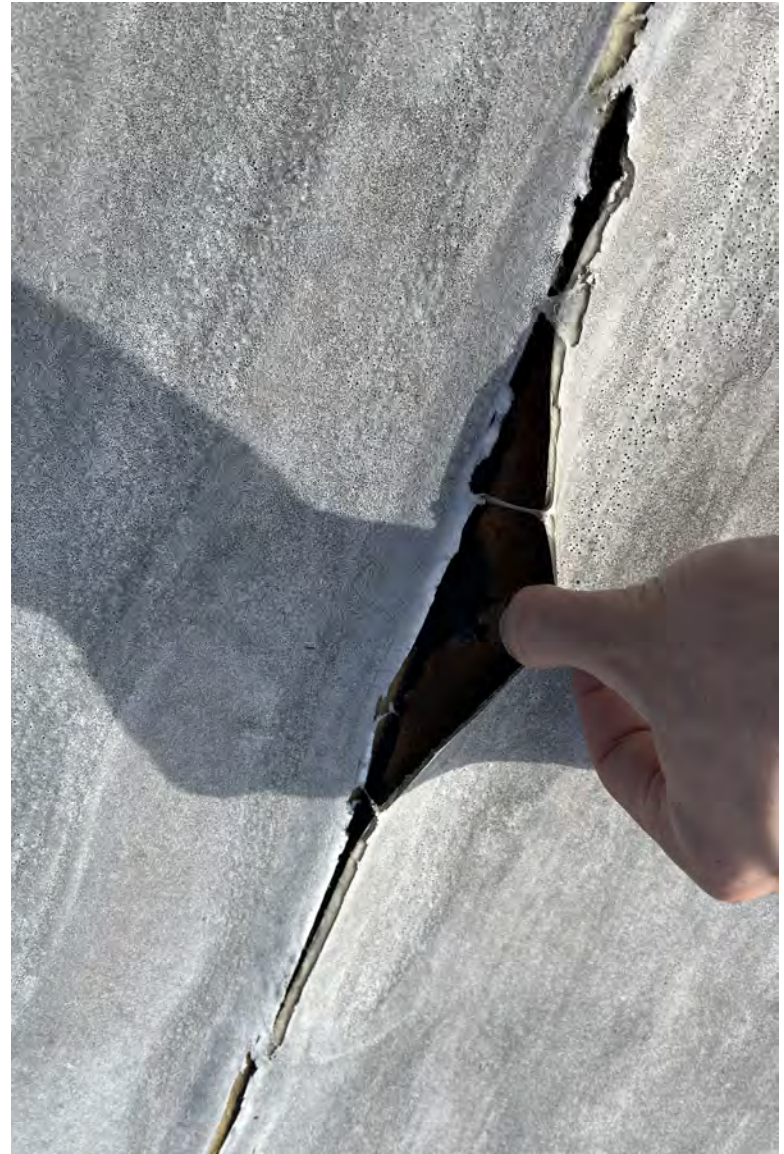
Hole in Membrane

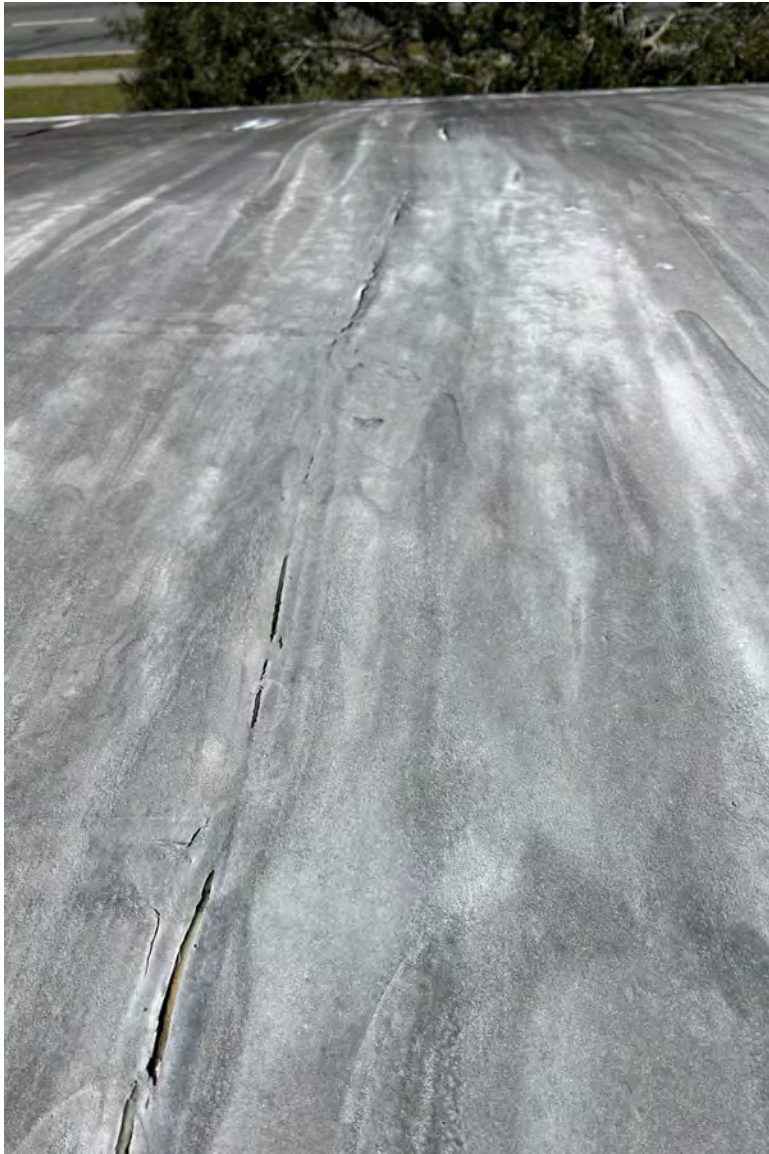
Hole in Membrane

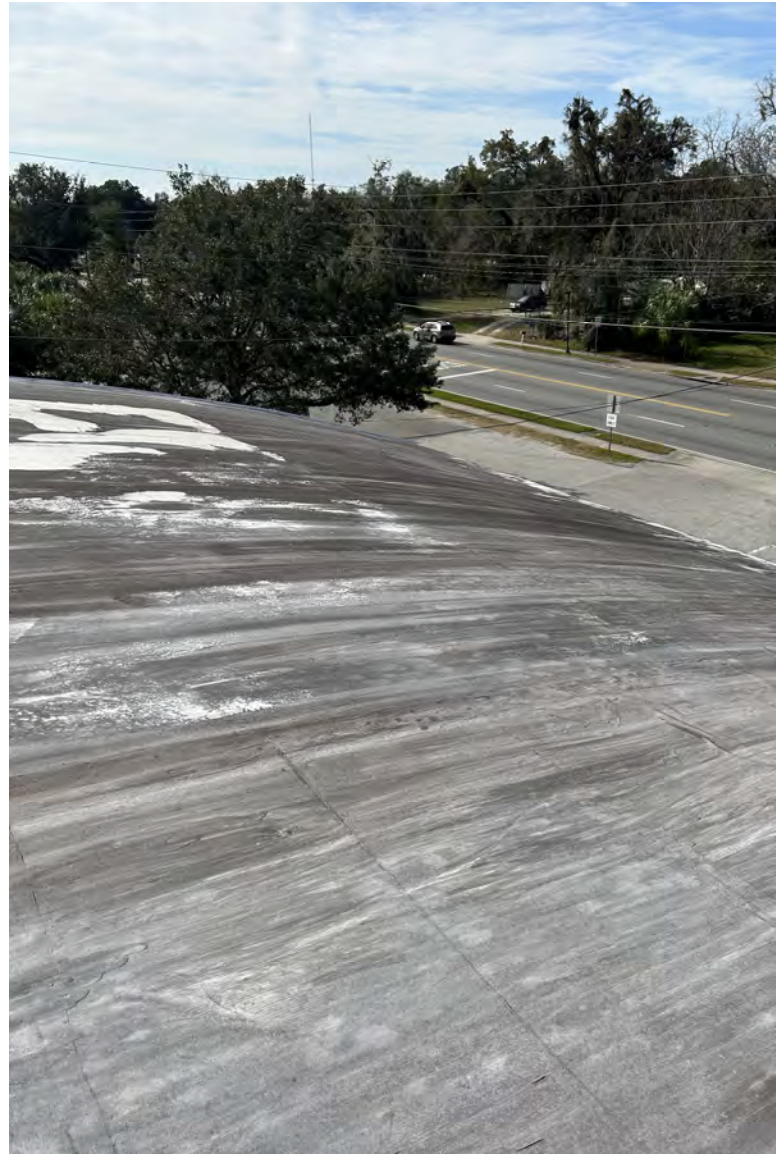
Hole in Membrane

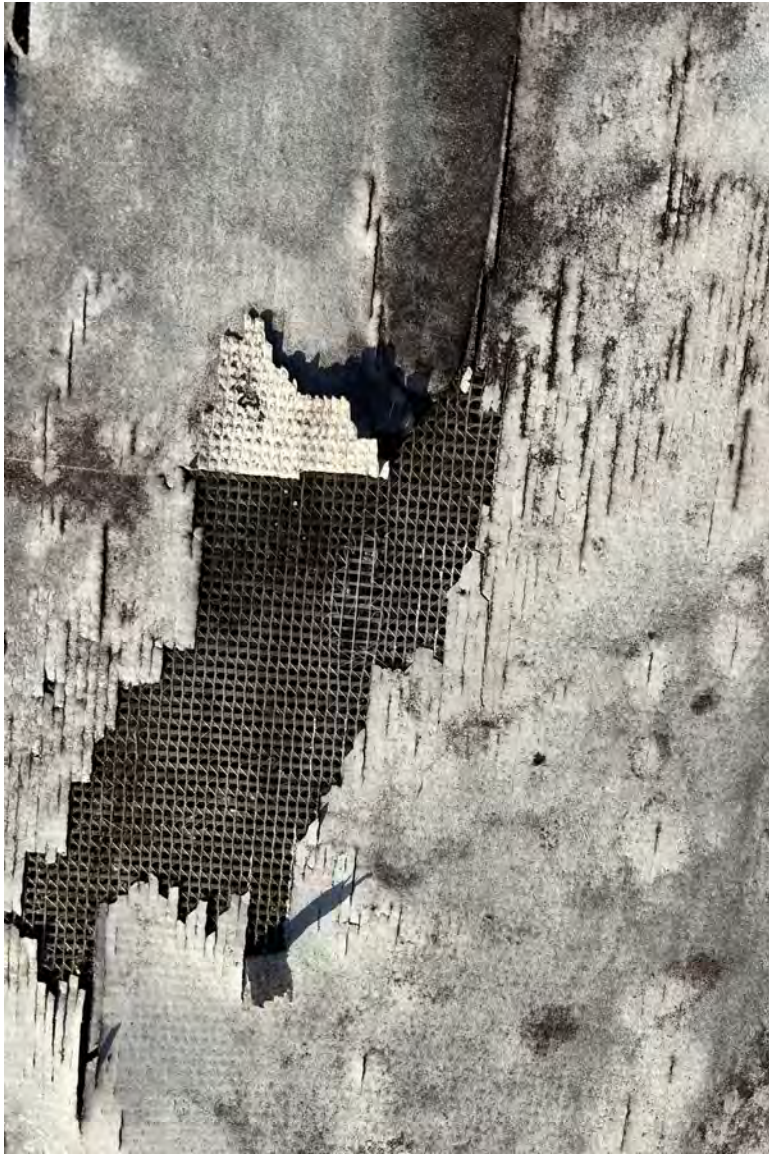
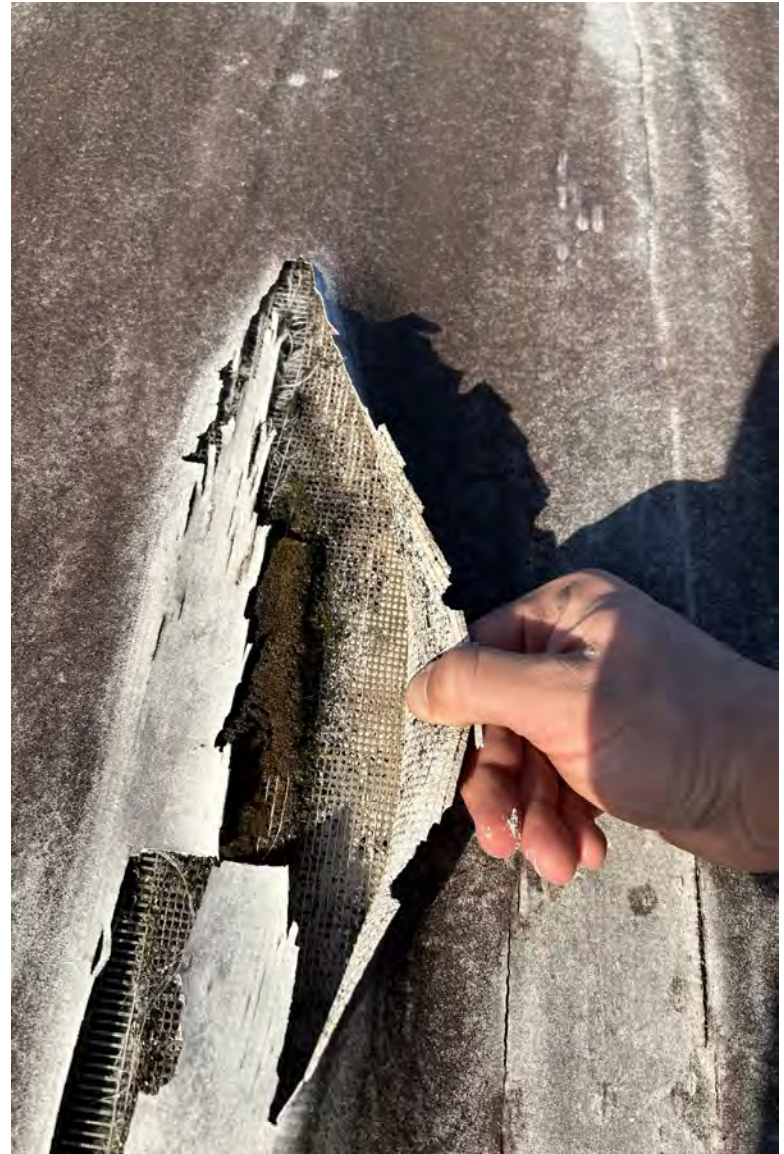
Failing Previous Repairs

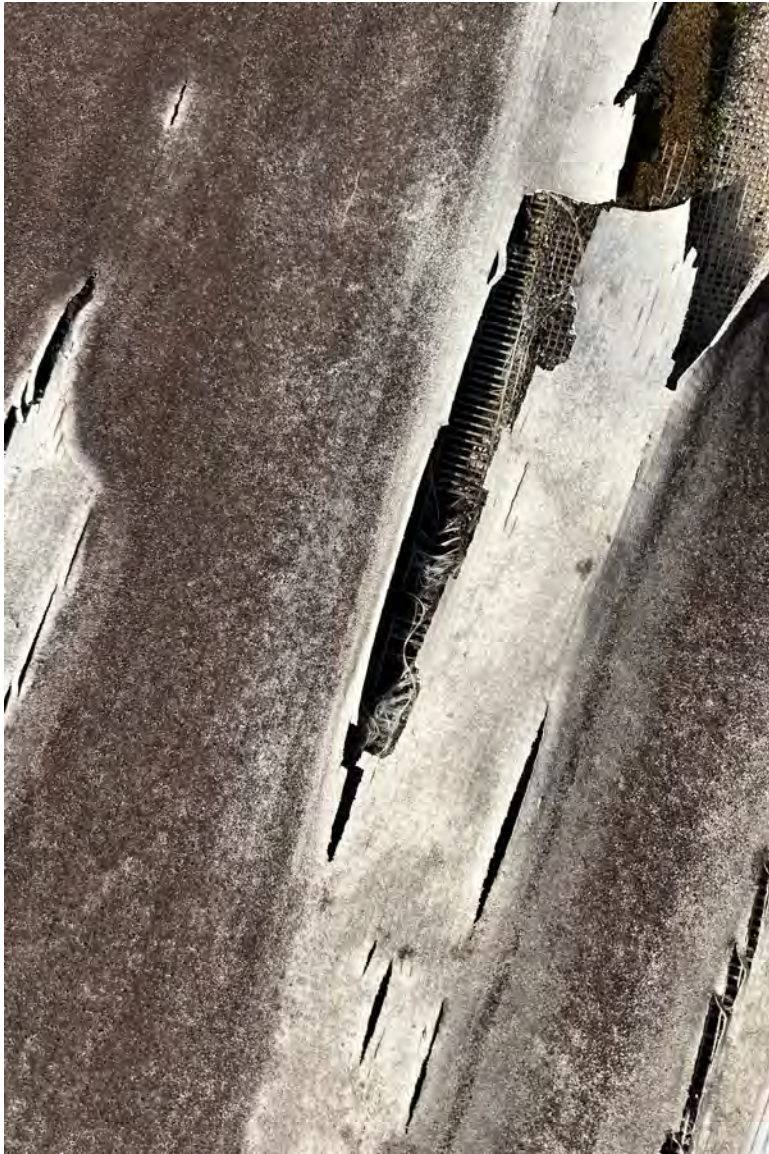
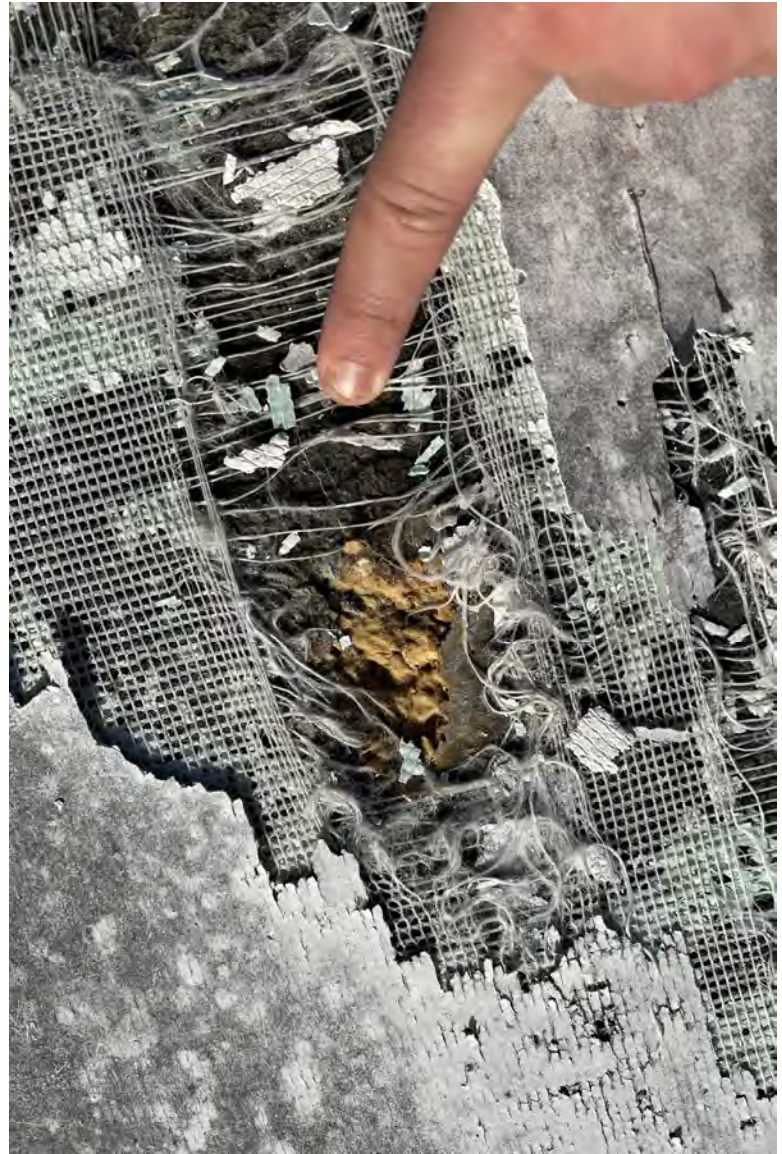
Holes in Roof

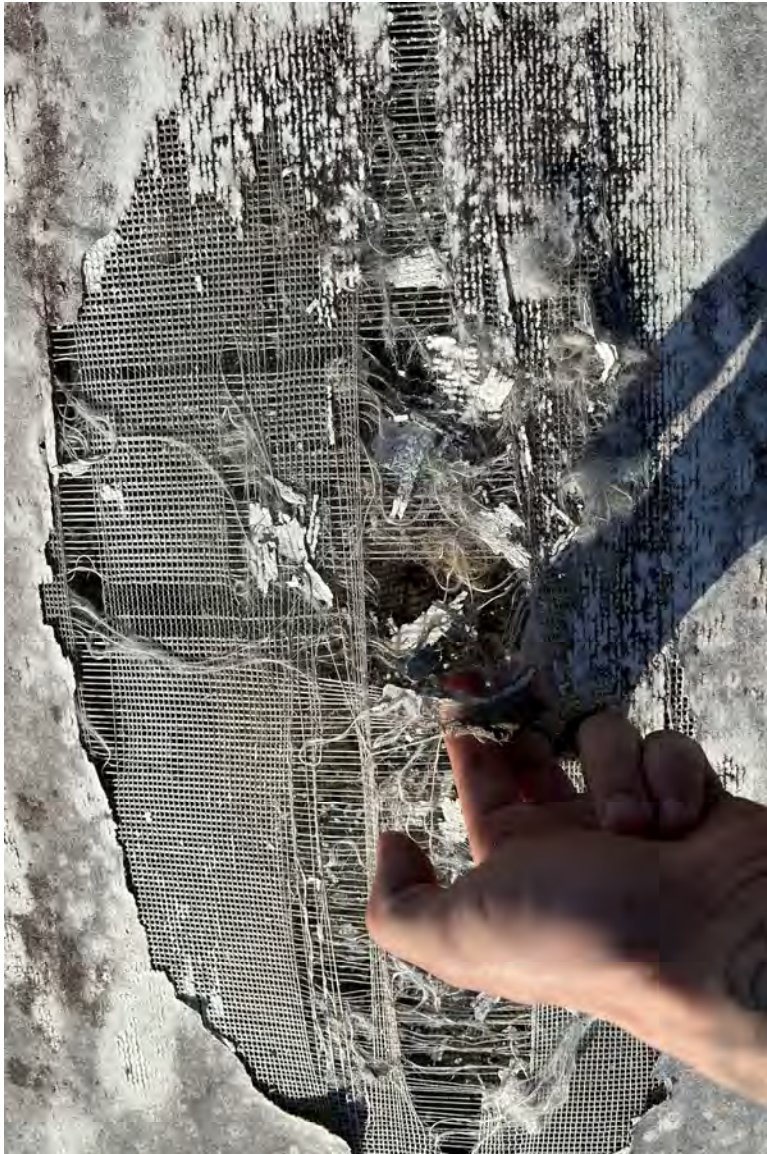
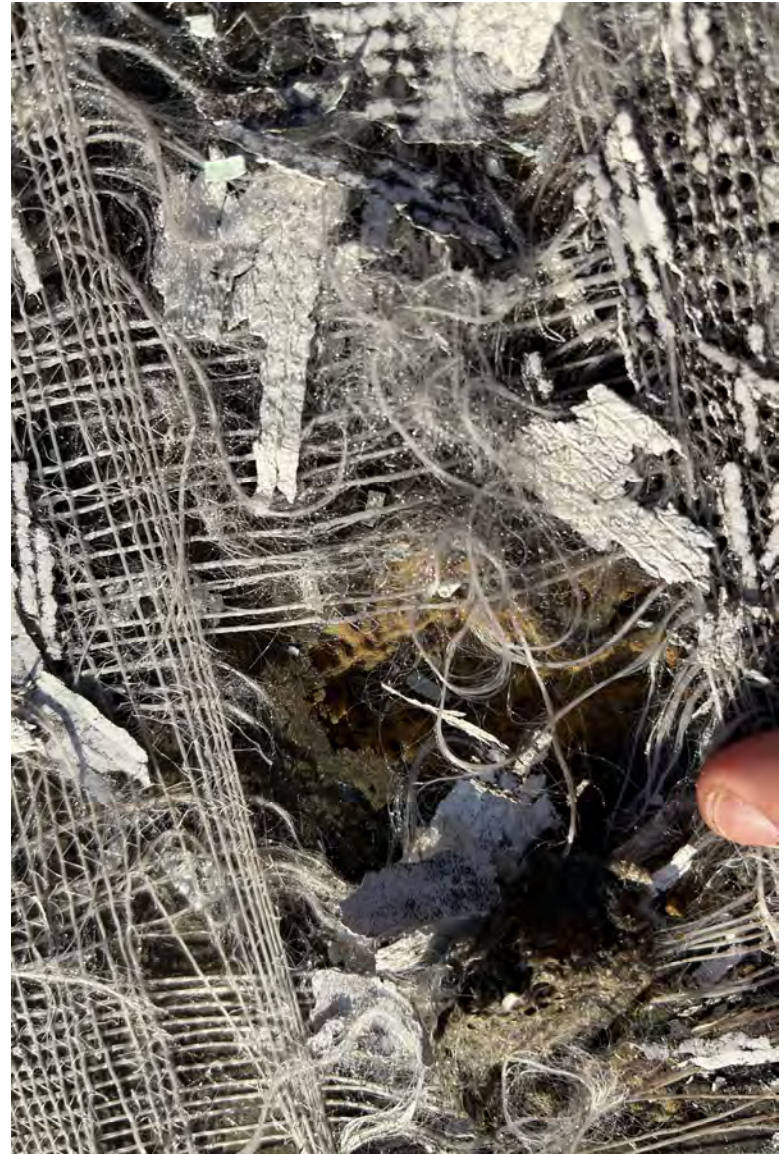
Holes in Roof

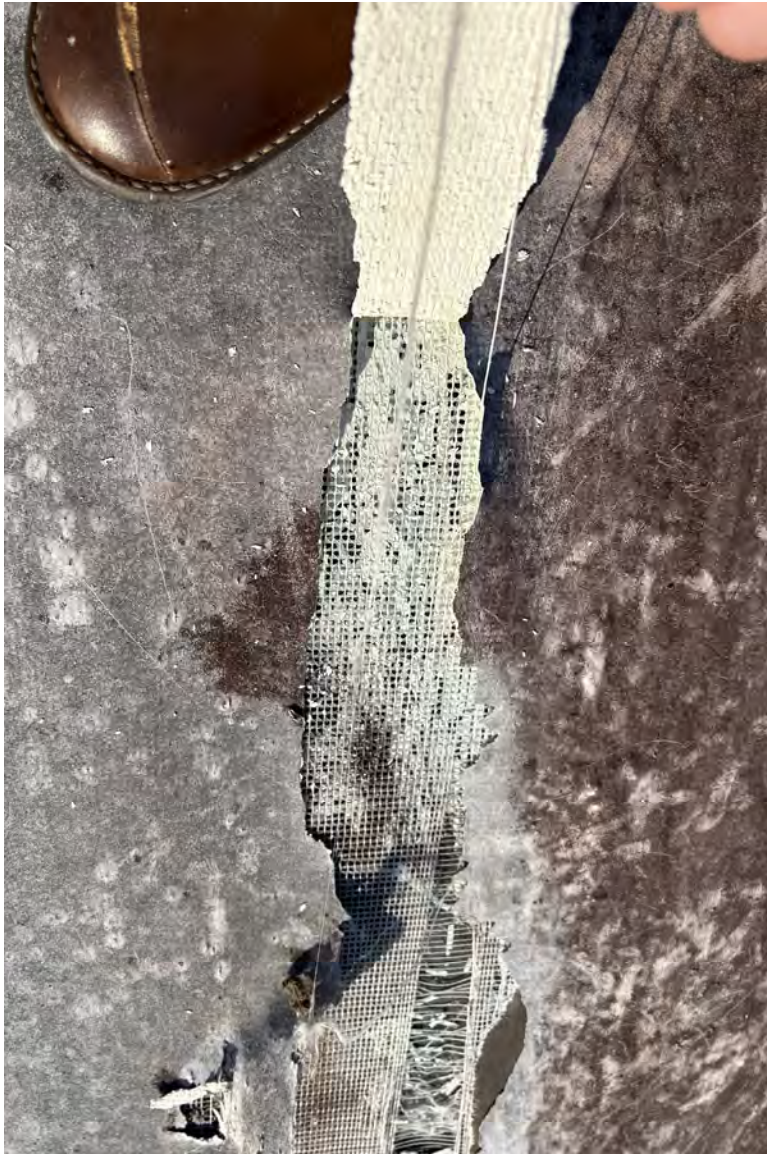
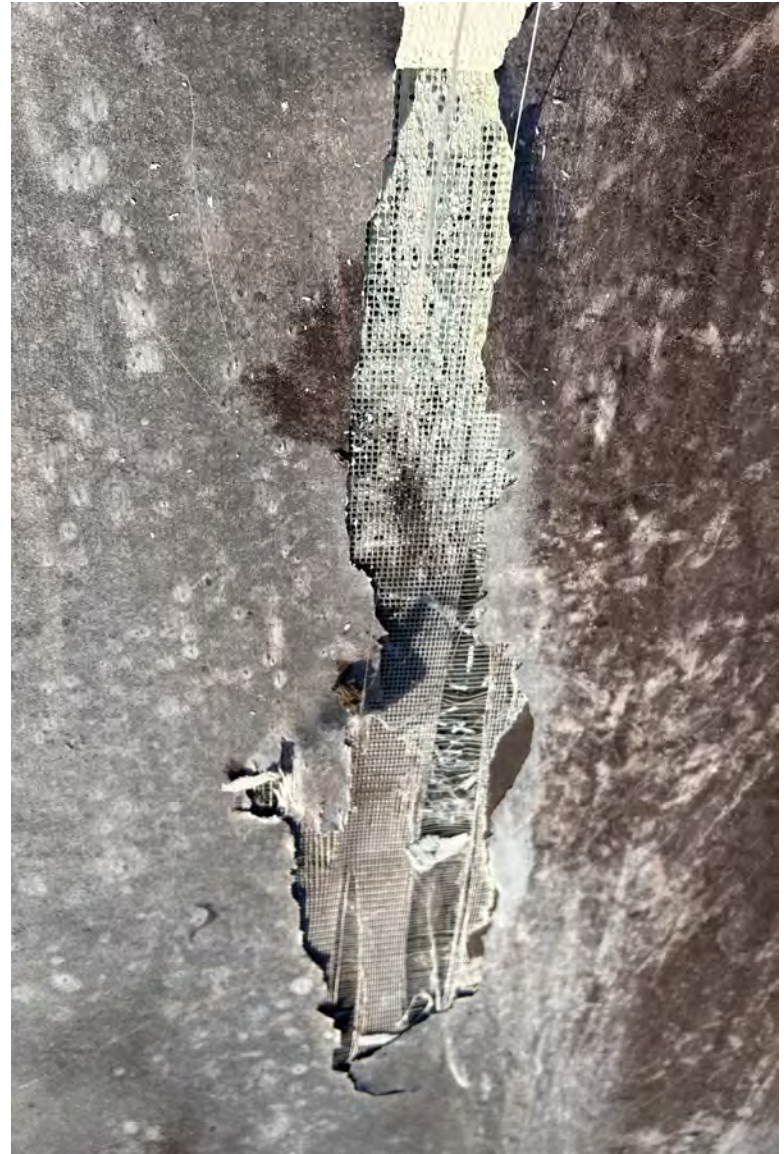
Holes in Membrane

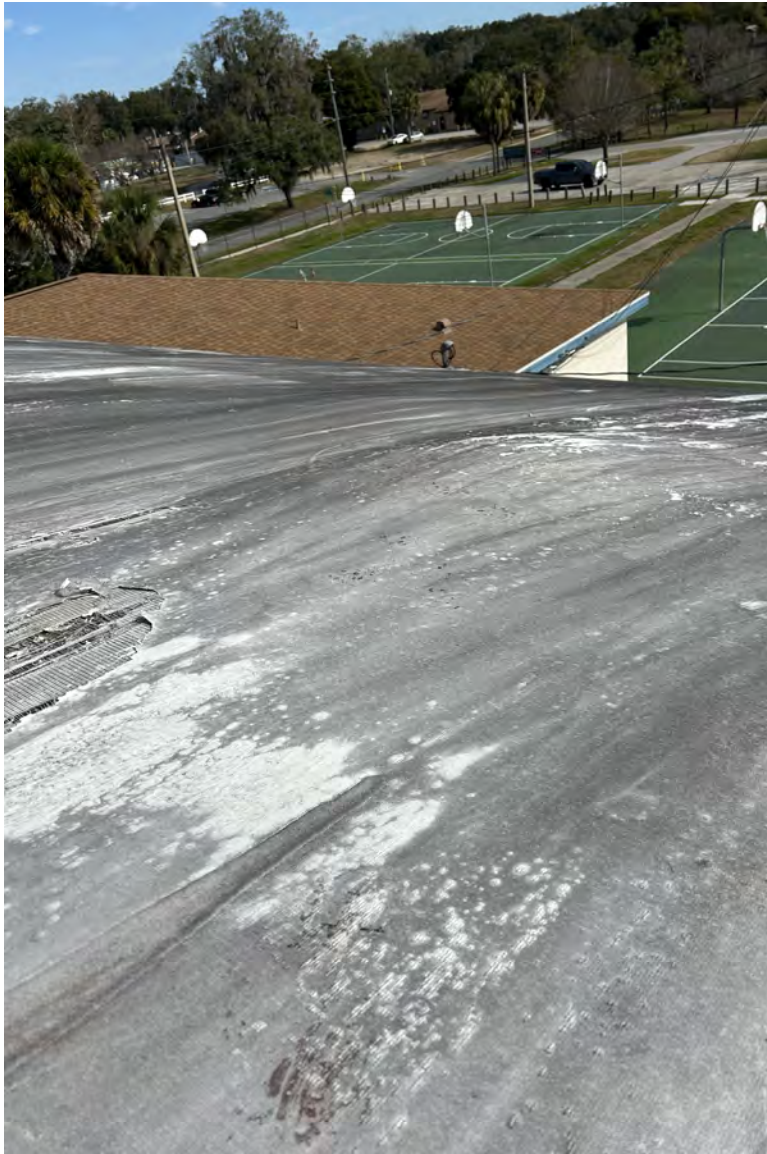
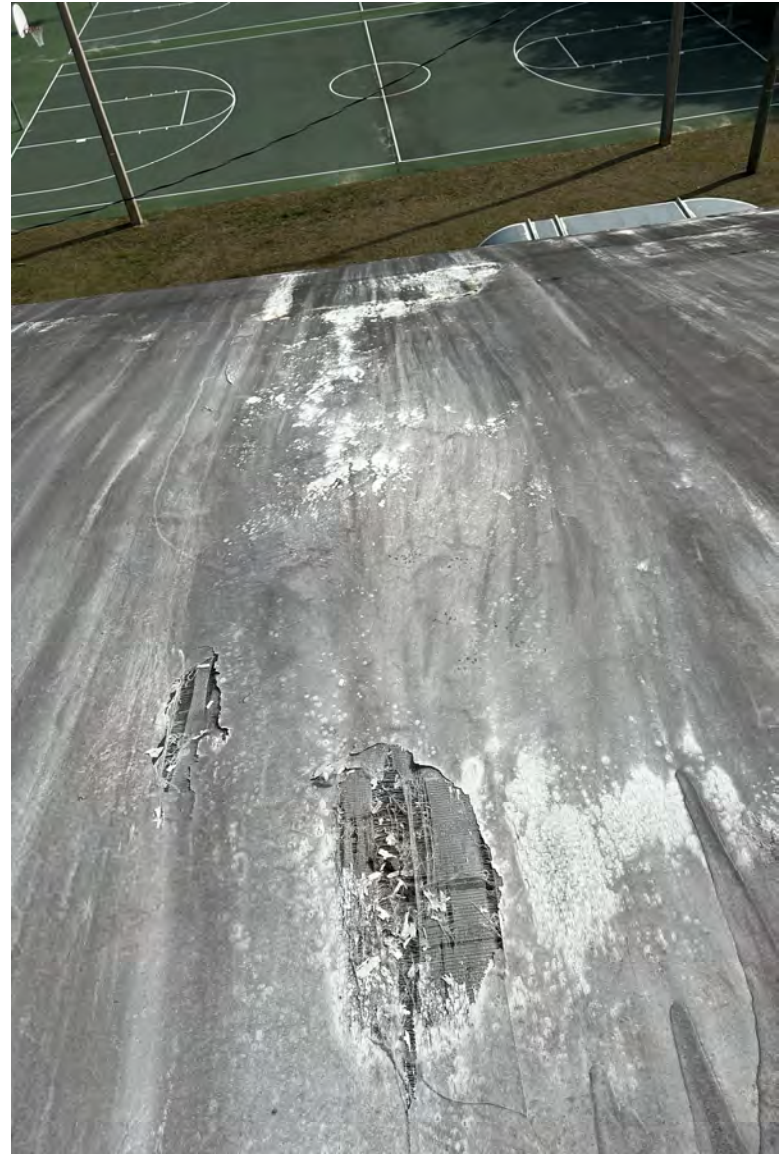
Holes in Membrane

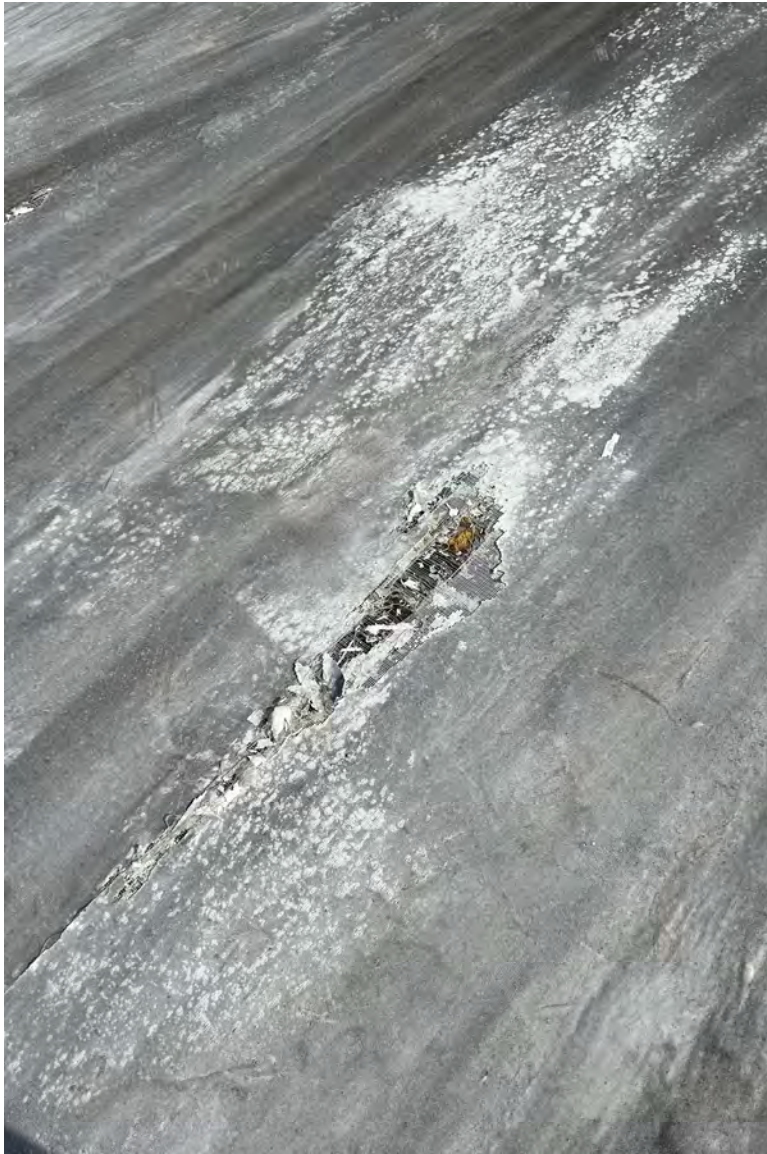
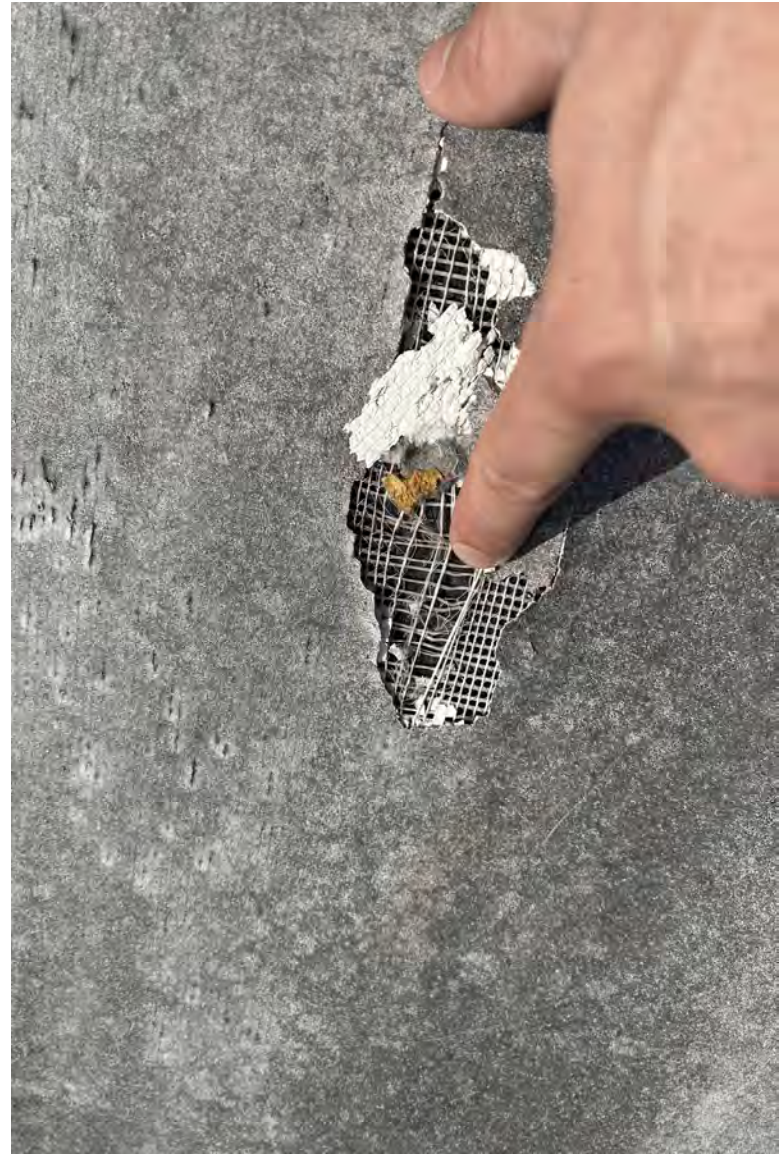
Holes in Membrane

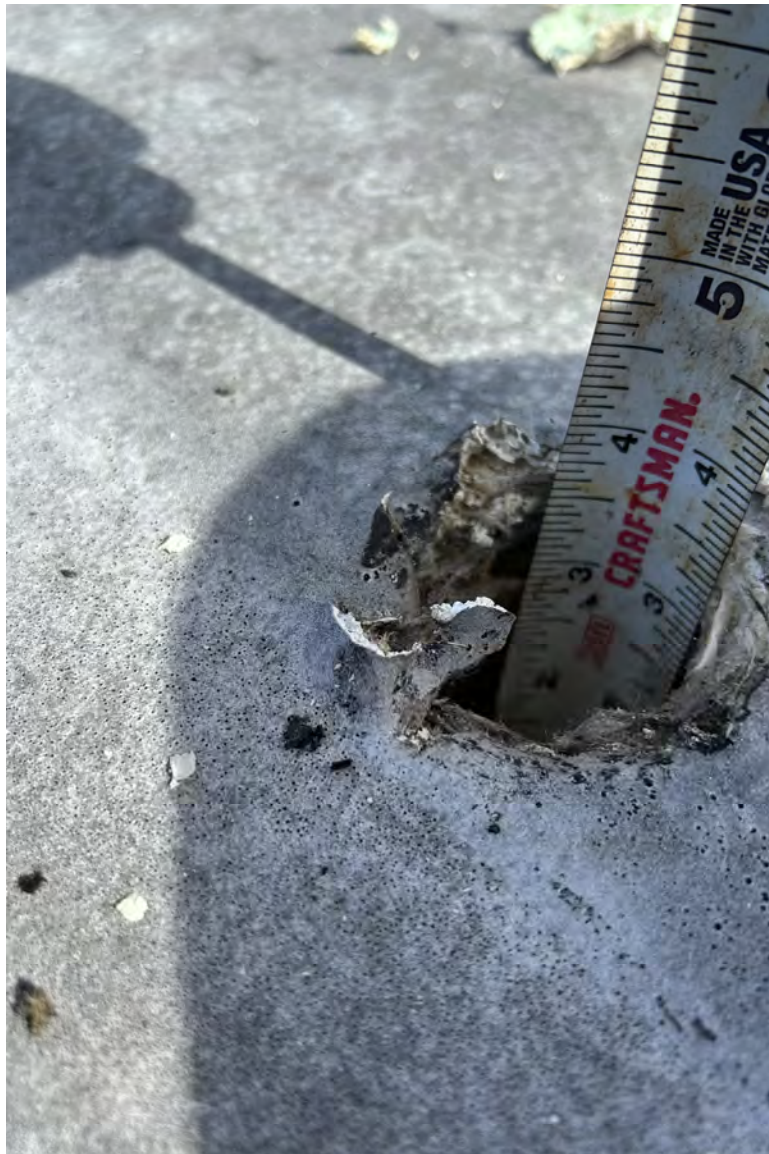
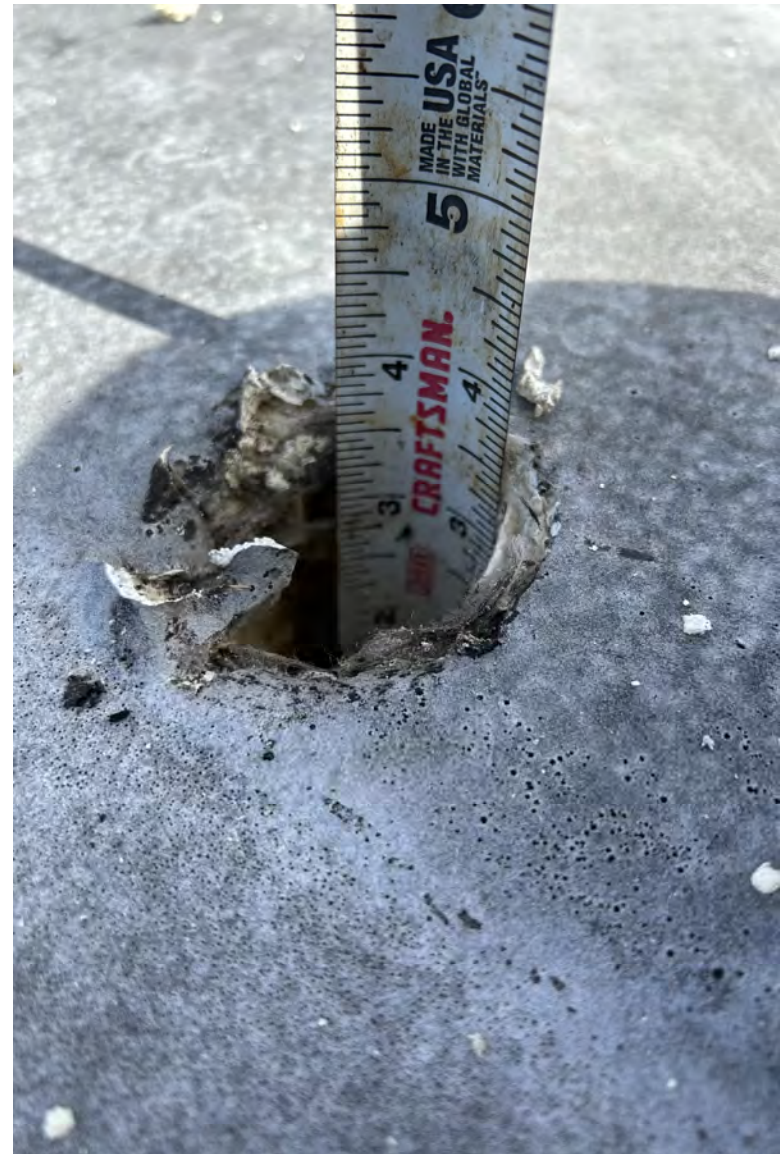
Holes in Membrane

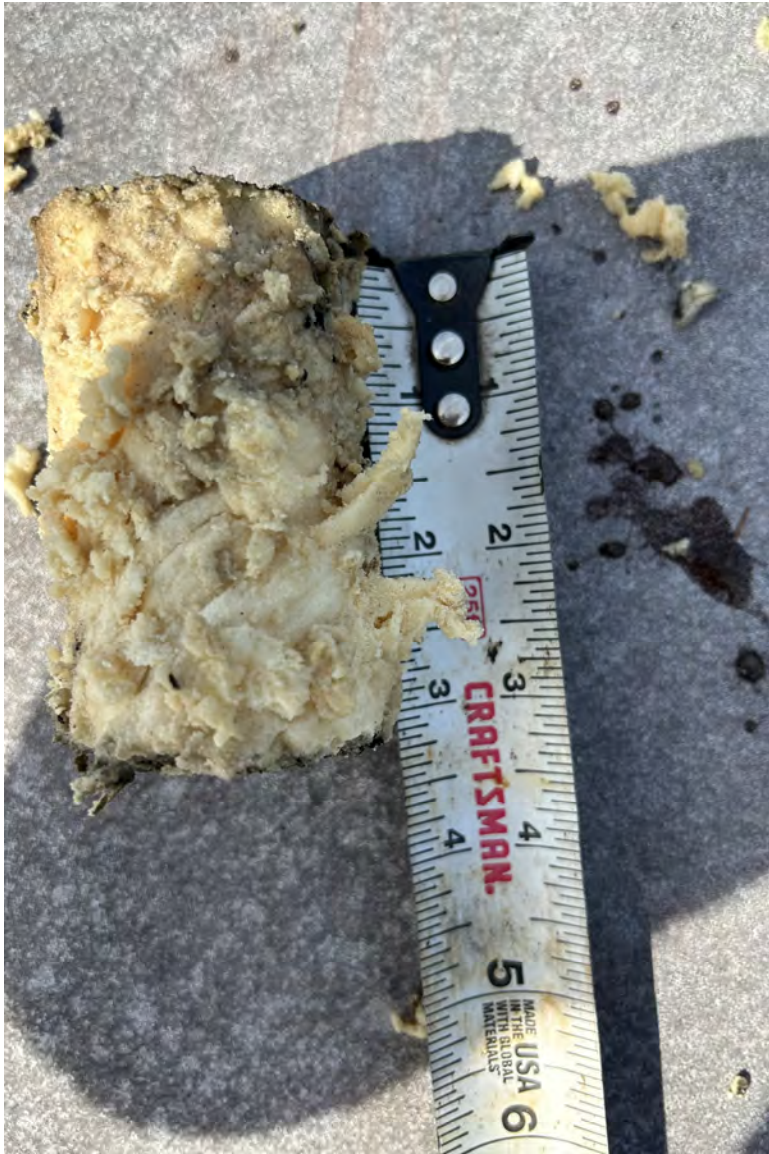
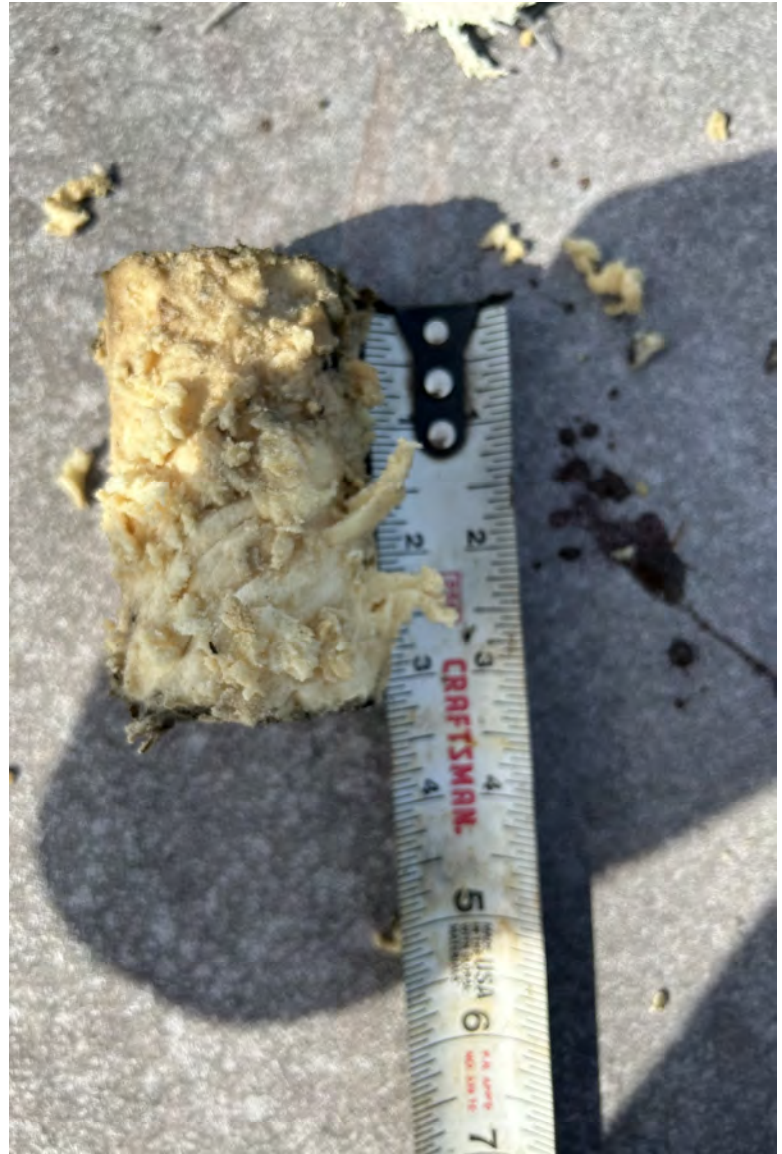
Core Cut Showing Wet Deck

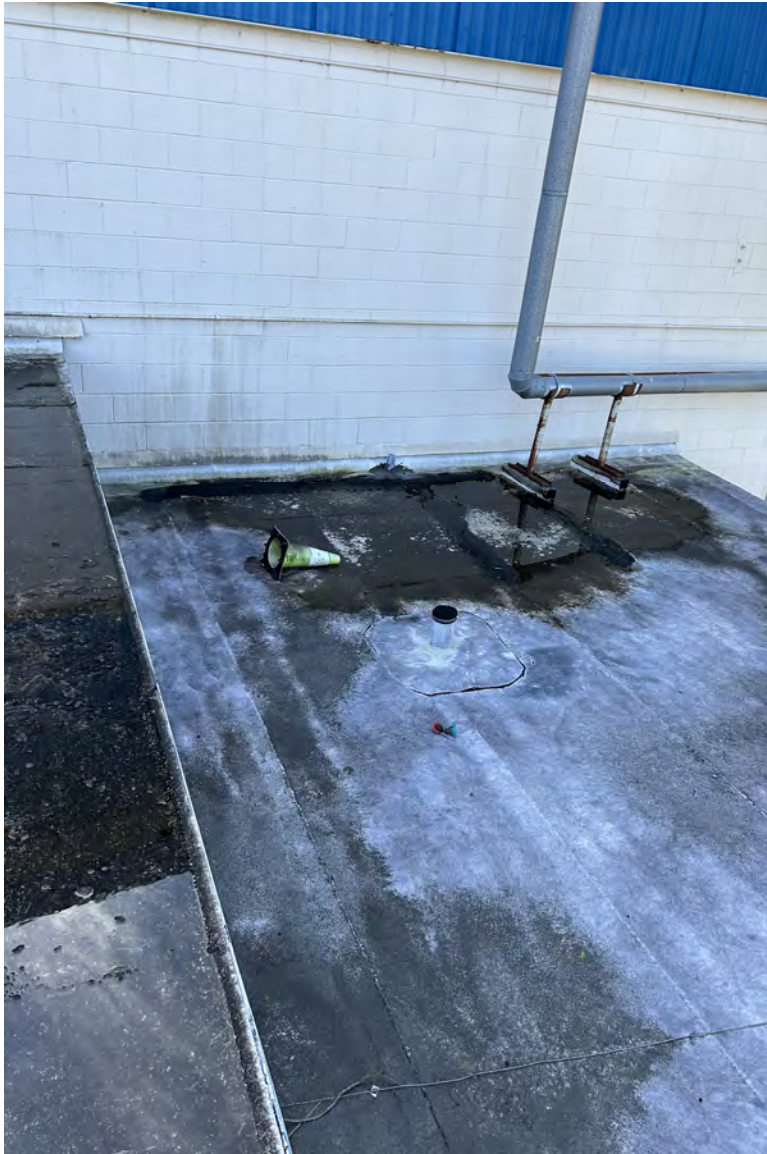
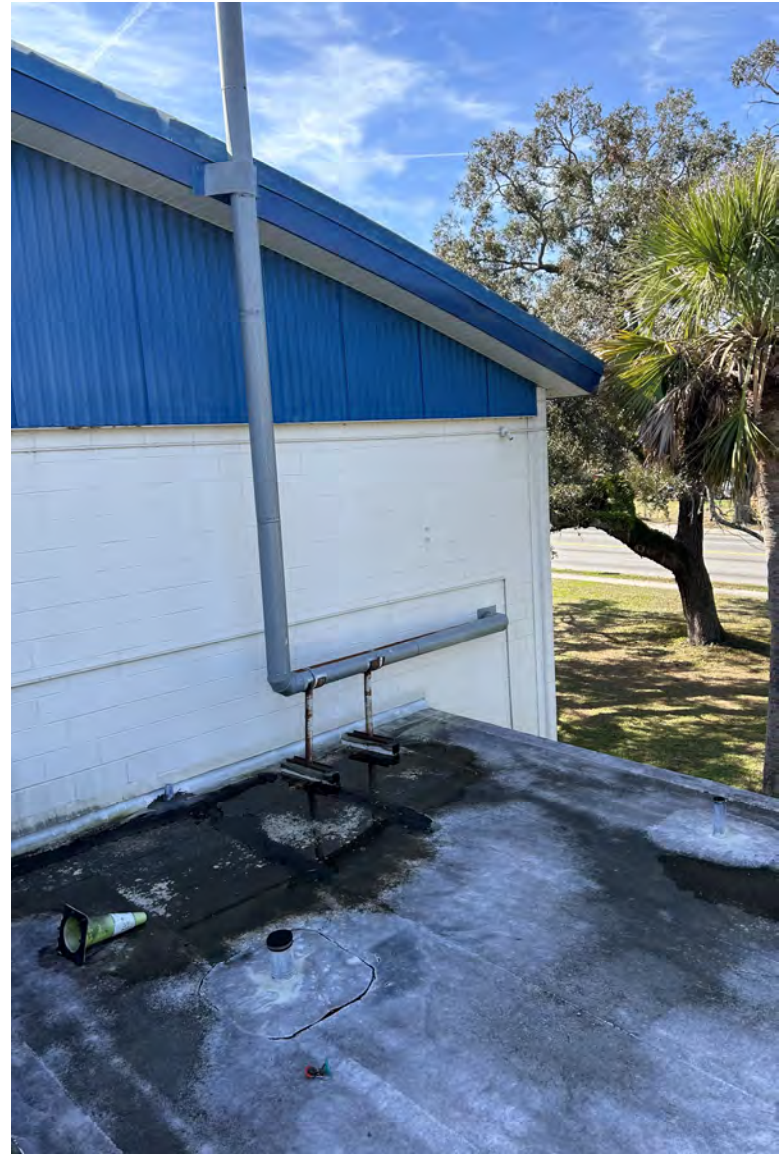
Ponding Water
