# Ed Croskey Rec Center

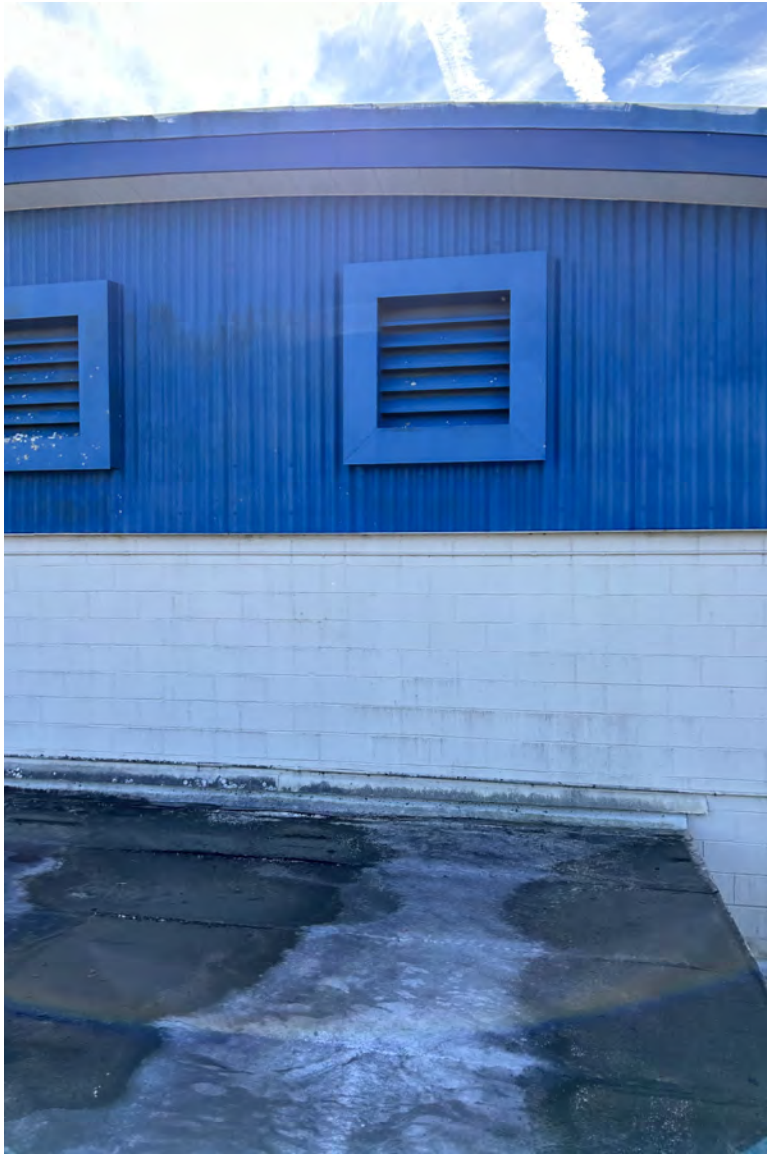
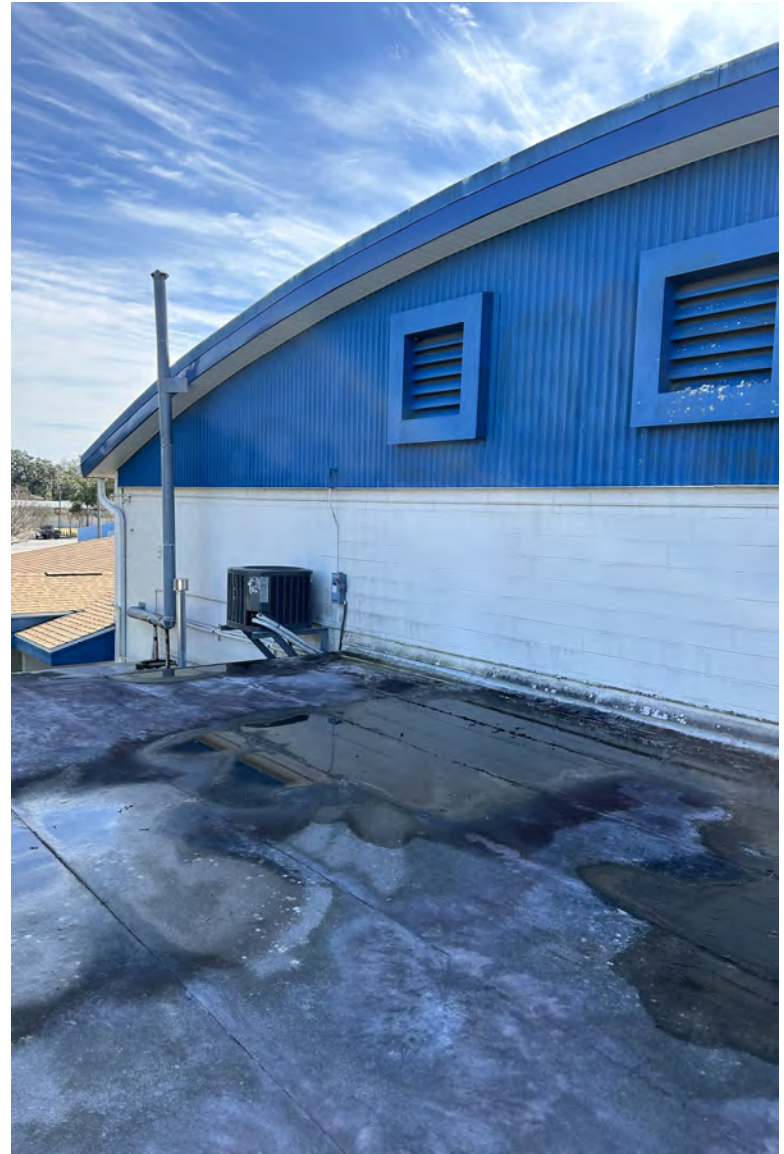
Ponding Water
