**A  
D & Associates Professional Inspections, Inc.  
P An Engineering Firm**

March 03, 2023

Re: **2023** Inspection of the *Jervey Gantt* and the *Hampton Aquatic* Water Facilities

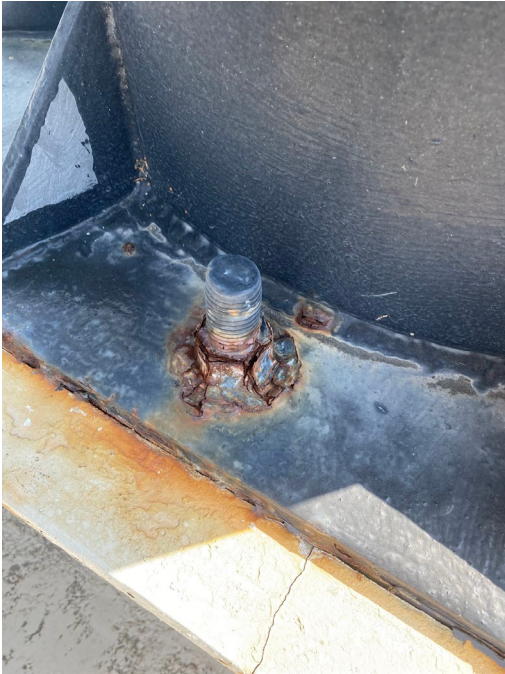
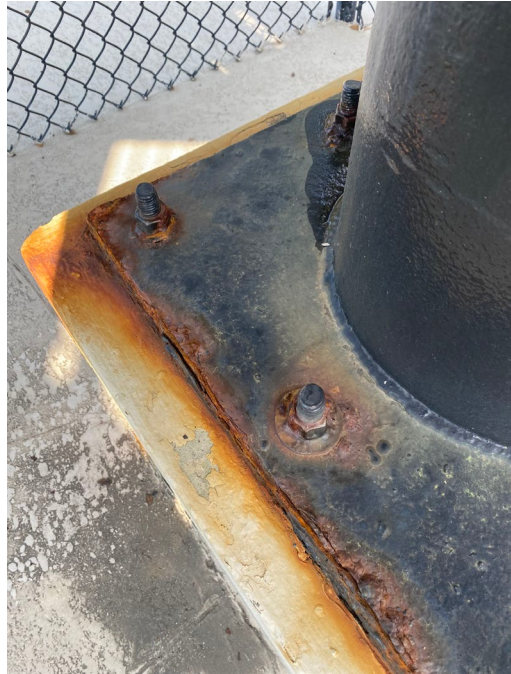
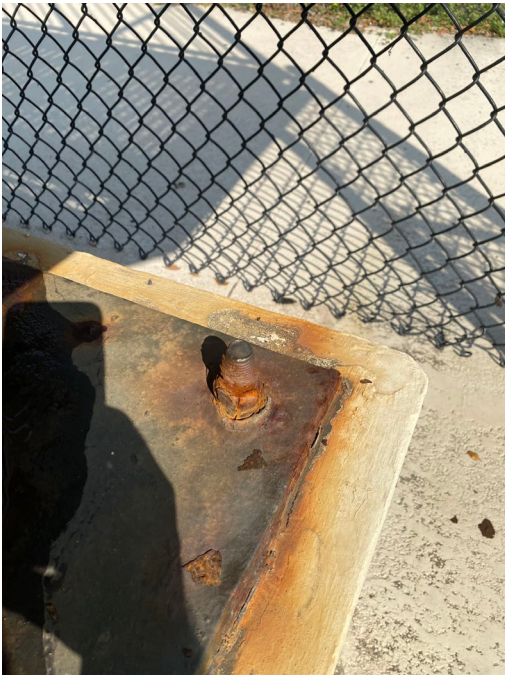
1. Corrosion was found on the mast foundation hardware (Figures 1 - 3). Recommend removing corrosion from these areas, and afterwards replace the nuts and washers with original manufactured specified hardware.
2. Corrosion was found on a portion of the stairs and platform substructure (Figure 4). Recommend removing corrosion from these areas and applying protective coating to prevent further corrosion.
3. A cracked slide support bracket was found located at the very end of the slide (Figures 5 - 7). This bracket must be repaired or replaced before using the slide.

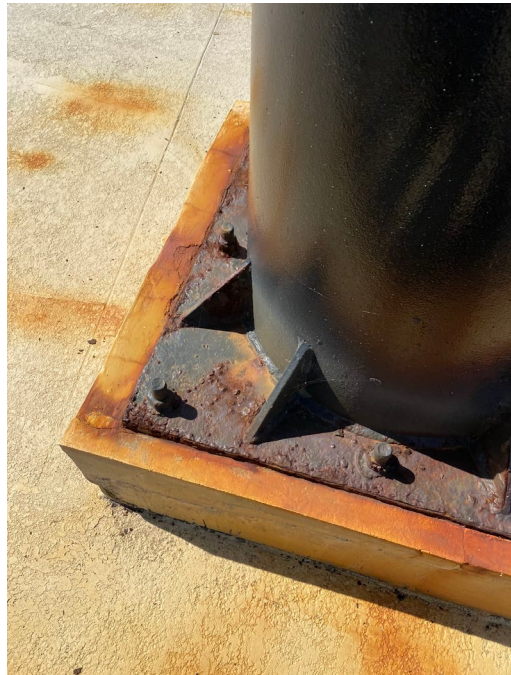
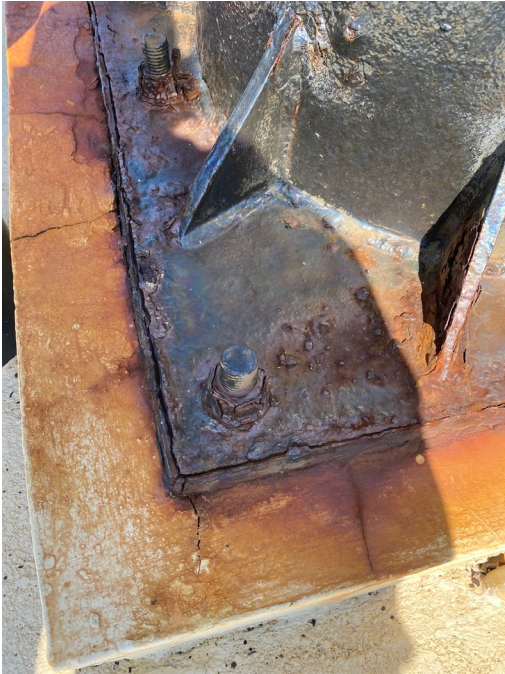
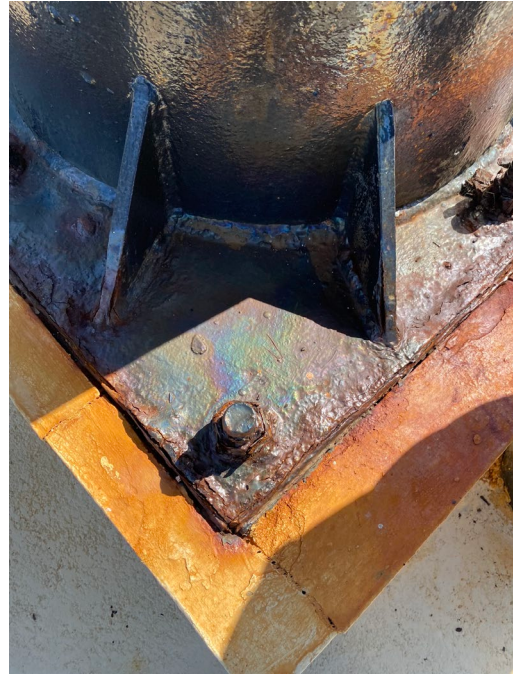
Corrosion was found on the mast foundation hardware (Figures 8 - 10). Recommend removing the corrosion from these areas, then afterwards replace the nuts and washers with original manufactured specified hardware.

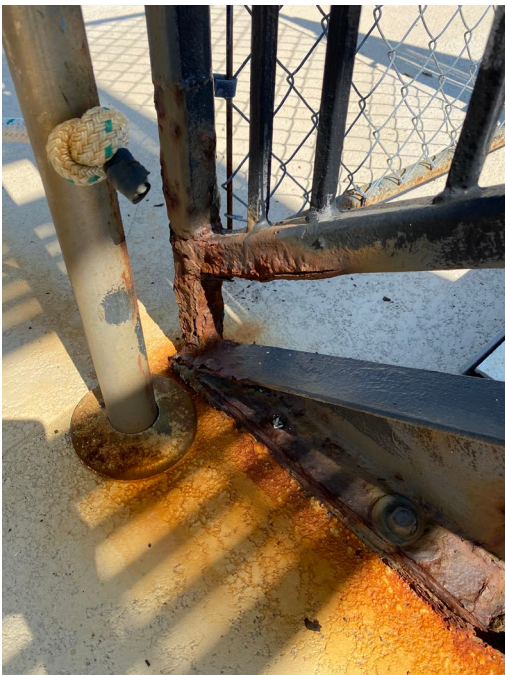
Figure 11

Significant corrosion was found on the handrail uprights (Figure 11). These uprights need to be repaired or replaced before using the slide.

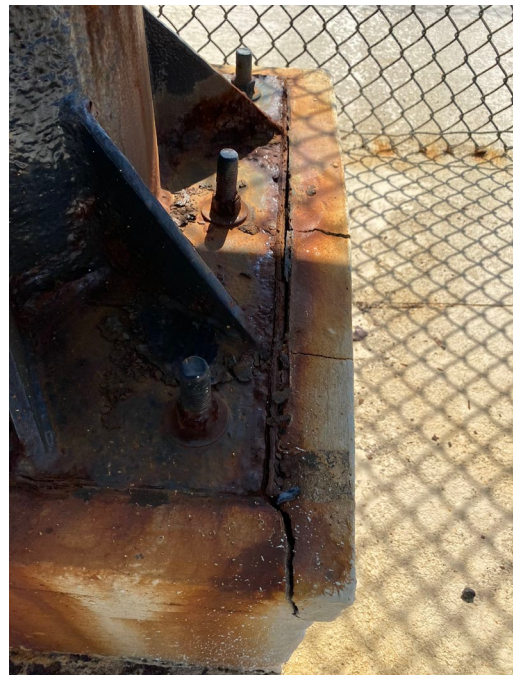
Figure 12

Areas of the concrete foundation are cracking (Figure 12). The cracking is caused by expansion of the steel base plate due to corrosion. The cracking is not significant to warrant foundation concerns, but the corrosion of the baseplate should be removed and protected to prevent further corrosion. The cracking can lead to pathways for moisture to enter further inside the concrete foundations and eventually cause the reinforcing steel to also corrode leading to more significant issues.

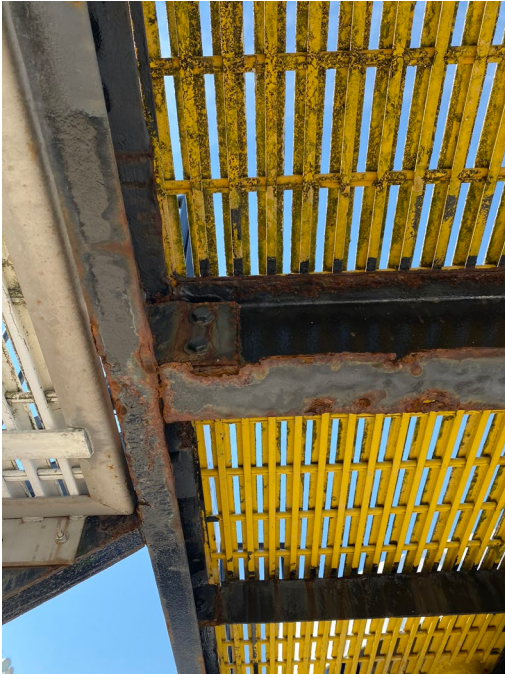
Figure 13

Several structural members supporting the top platform have significant corrosion and material loss (Figures 13 - 15). The central I beam has material loss on both the top and bottom flanges and needs to be repaired or replaced before use. There are also two steel angle members (Figures 14 & 15) that support the floor showing significant corrosion and material loss. These members need to be repaired or replaced before use.

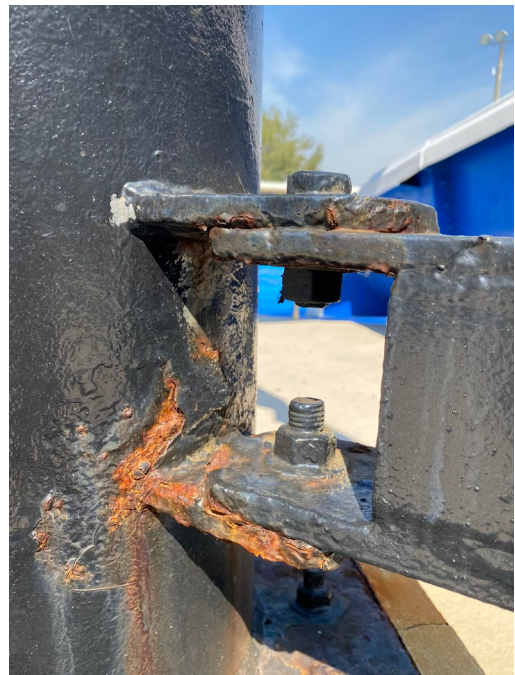
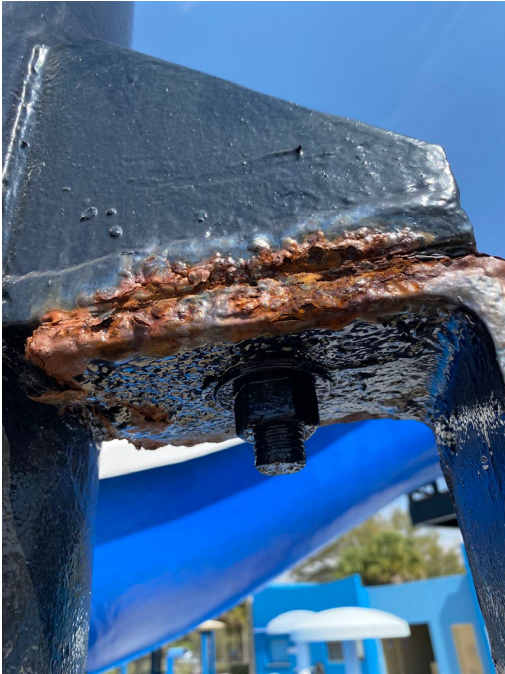
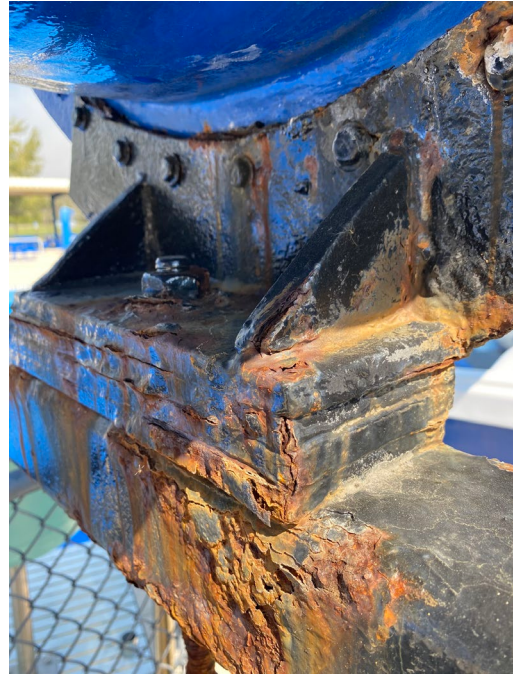
Corrosion was found on the slide mast and slide support mast arms (Figures 16 - 18). Recommend removing corrosion from these areas and applying protective coating to prevent further corrosion.

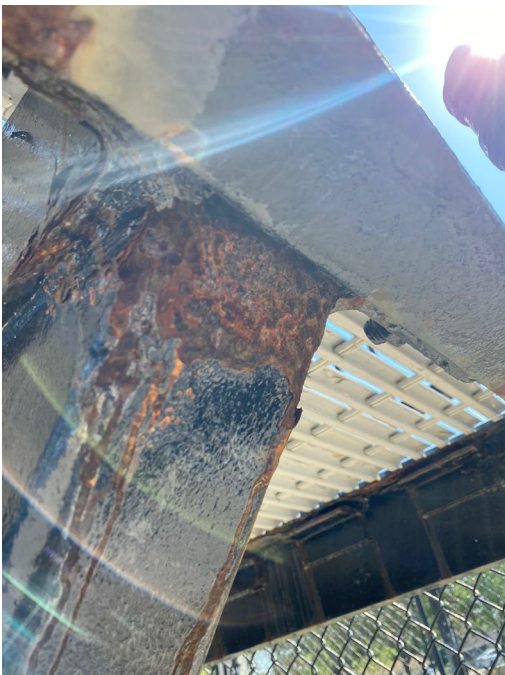
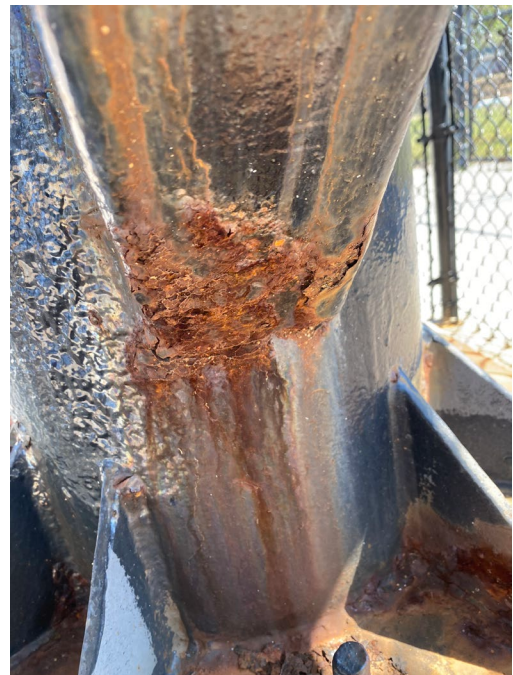
Corrosion was found on an angled section of the substructure supporting the stairs (Figures 19 & 20). The corrosion here is significant and needs to be investigated. After the corrosion is completely removed to see the extent of material loss, it can then be determined if repair or replacement is needed.
