**FLORIDA MASTER SITE FILE  
Site Inventory Form**

Site Name \_\_\_\_\_  
Address of Site: 1116 S.E. 5th St.  
Instruction for locating 1116 S.E. 5th St. 813 = =  
Ocala, Fla. 32671 868 = =  
Location: Caldwells Ad, Com. 14.74 1/2 chs. E. of NE Cor. of Bk. 35, thence  
subdivision name block no. lot no. 808 = =  
County: Marion  
Owner of Site: Name: Shashy, S. A. Moses & M.S.  
Address: 1116 S.E. 5th St. 902 = =  
Ocala, Fla. 32671 832 = =  
Type of Ownership Private 848 = = Recording Date \_\_\_\_\_  
Recorder: \_\_\_\_\_  
Name & Title: Tate, Susan (Preservation Architect)  
Address: University of Florida - College of Architecture 818 = =  
Gainesville, Fla. 32611 838 = =  
Condition of Site: Integrity of Site: Original Use Residence  
Check One Check One or More Present Use Residence 850 = =  
 Excellent 863 = =  Altered 858 = = Dates: Beginning C+ 1938 844 = =  
 Good 863 = =  Unaltered 858 = = Culture/Phase American 840 = =  
 Fair 863 = =  Original Site 858 = = Period 20th Century 845 = =

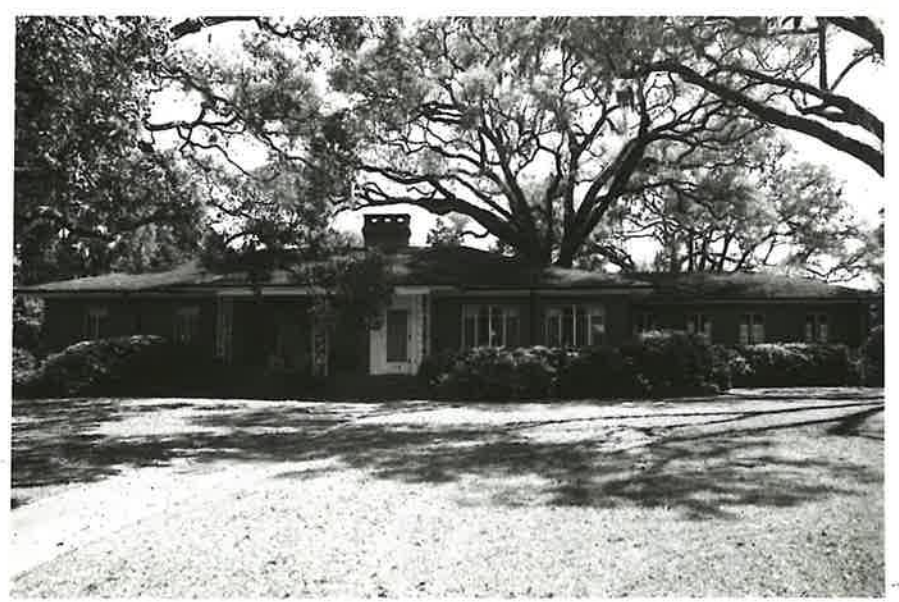
Photographic Records Numbers  
83 N 41 # 8 (6,7)  
 Contact Print

**Significance:**  
This house is in Caldwell's Ad Buffums Subdivision platted in 1882 and first appears on the Tax Record for 1938. This is a single story brick residence with metal awning windows.
