### FLORIDA MASTER SITE FILE Site Inventory Form

Site No. 31-(51790) 2920-027-007  
830 = = Survey Date 1981 820 = =  
905 = =

Address of Site: 713 S. E. 2nd St.  
Instruction for locating Second house east of S.E. Sanchez Ave. on north side of S.E. 2nd Ave. E OF SW COR. OF BLK 27 TH 813 = =

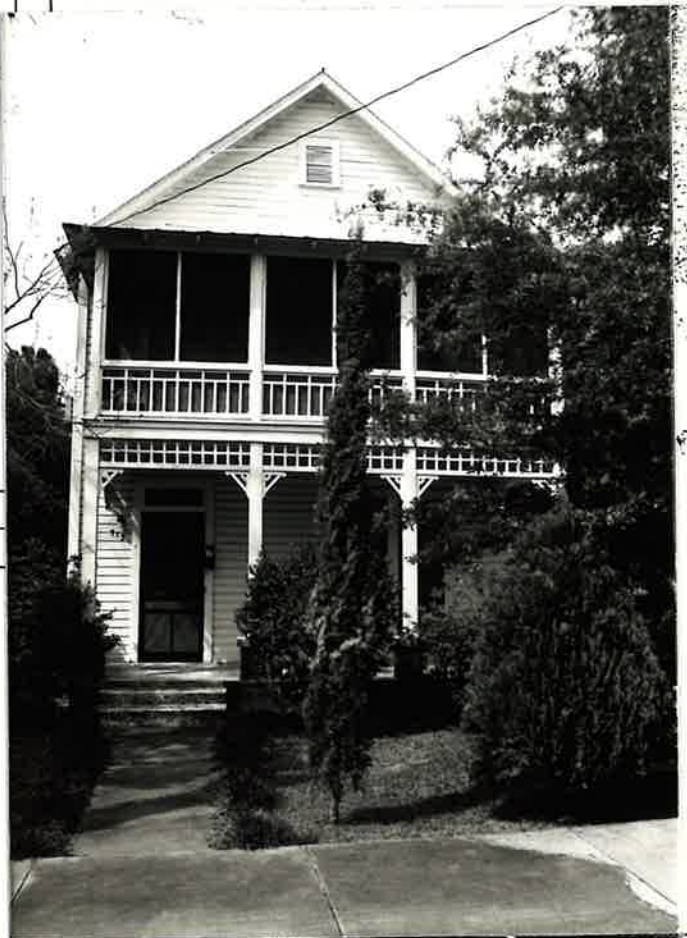
Contact Print

An example of a Victorian frame vernacular style house exhibiting stick style architectural influences. The house is in scale and character with its surroundings, a residential Victorian neighborhood which has evolved from the 1880's through the early 1900's.

ARCHITECT \_\_\_\_\_ 872 ==  
 BUILDER \_\_\_\_\_ 874 ==  
 STYLE AND/OR PERIOD frame vernacular Victorian 984 ==  
 PLAN TYPE central 966 ==  
 EXTERIOR FABRIC(S) shiplap wood siding 854 ==  
 STRUCTURAL SYSTEM(S) frame 856 ==  
 PORCHES front - upper & lower story double stacked  
 \_\_\_\_\_ 942 ==  
 FOUNDATION: brick pier 942 ==  
 ROOF TYPE: gable 942 ==  
 SECONDARY ROOF STRUCTURE(S): shed over balcony porch 942 ==  
 CHIMNEY LOCATION: E of ridge - interior 942 ==  
 WINDOW TYPE: double hung sash 942 ==  
 CHIMNEY: brick 882 ==  
 ROOF SURFACING: tin 882 ==  
 ORNAMENT EXTERIOR: stick style railing 882 ==  
 NO. OF CHIMNEYS 1 952 == NO. OF STORIES 2 950 ==  
 NO. OF DORMERS --- 954 ==  
 Map Reference (Incl. scale & date) USGS Ocala West - #447 - 7.5 Min. - 1964  
 \_\_\_\_\_ 809 ==  
 Latitude and Longitude: \_\_\_\_\_ 800 ==  
 Site Size (Approx. Acreage of Property): \_\_\_\_\_ 833 ==
