City of Ocala
Community Redevelopment Agency
201 SE 3rd Street, Ocala, FL 34471

MEMORANDUM

CRA24-45723 – 606 SE 3rd Ave

Inspection Report

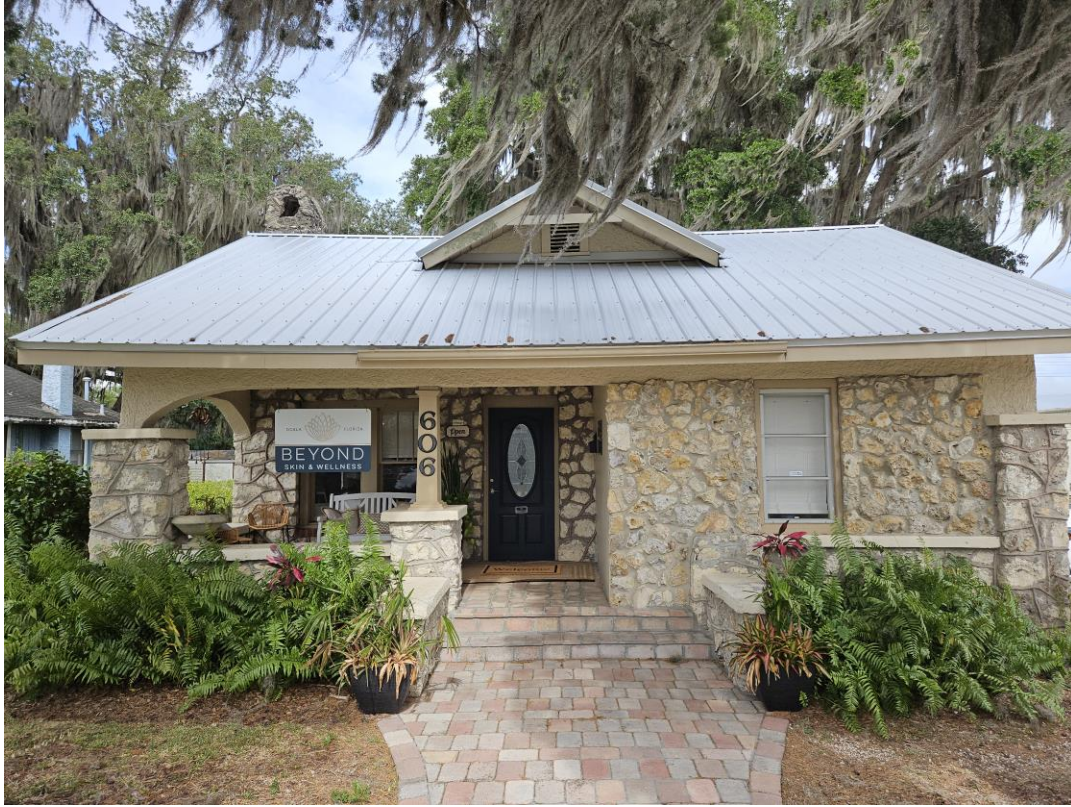
Image 1- Existing conditions- façade.

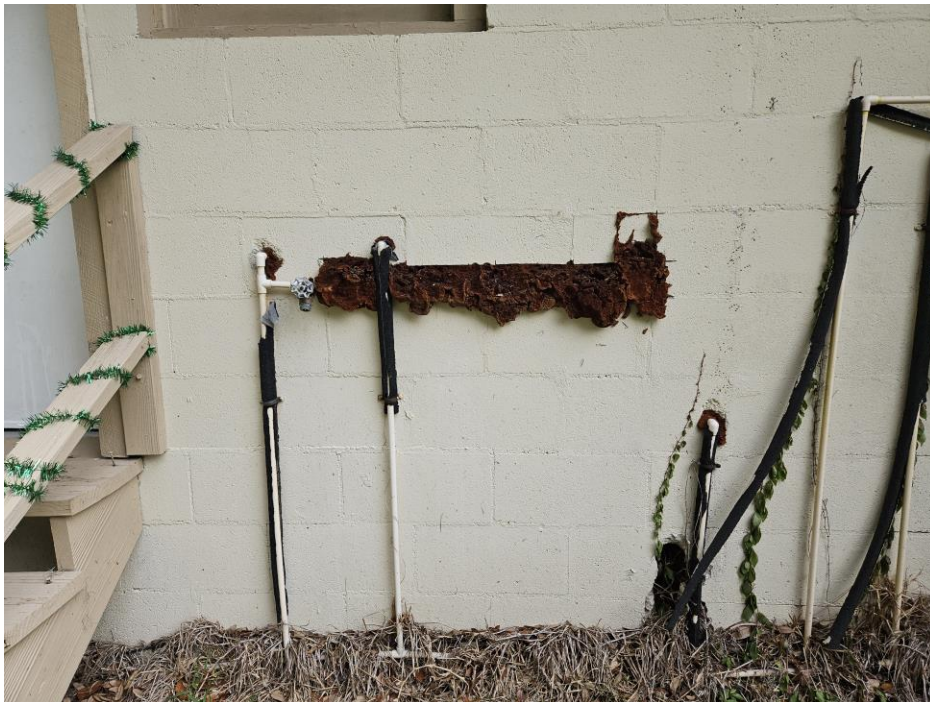
Image 2- Existing conditions - plumbing.

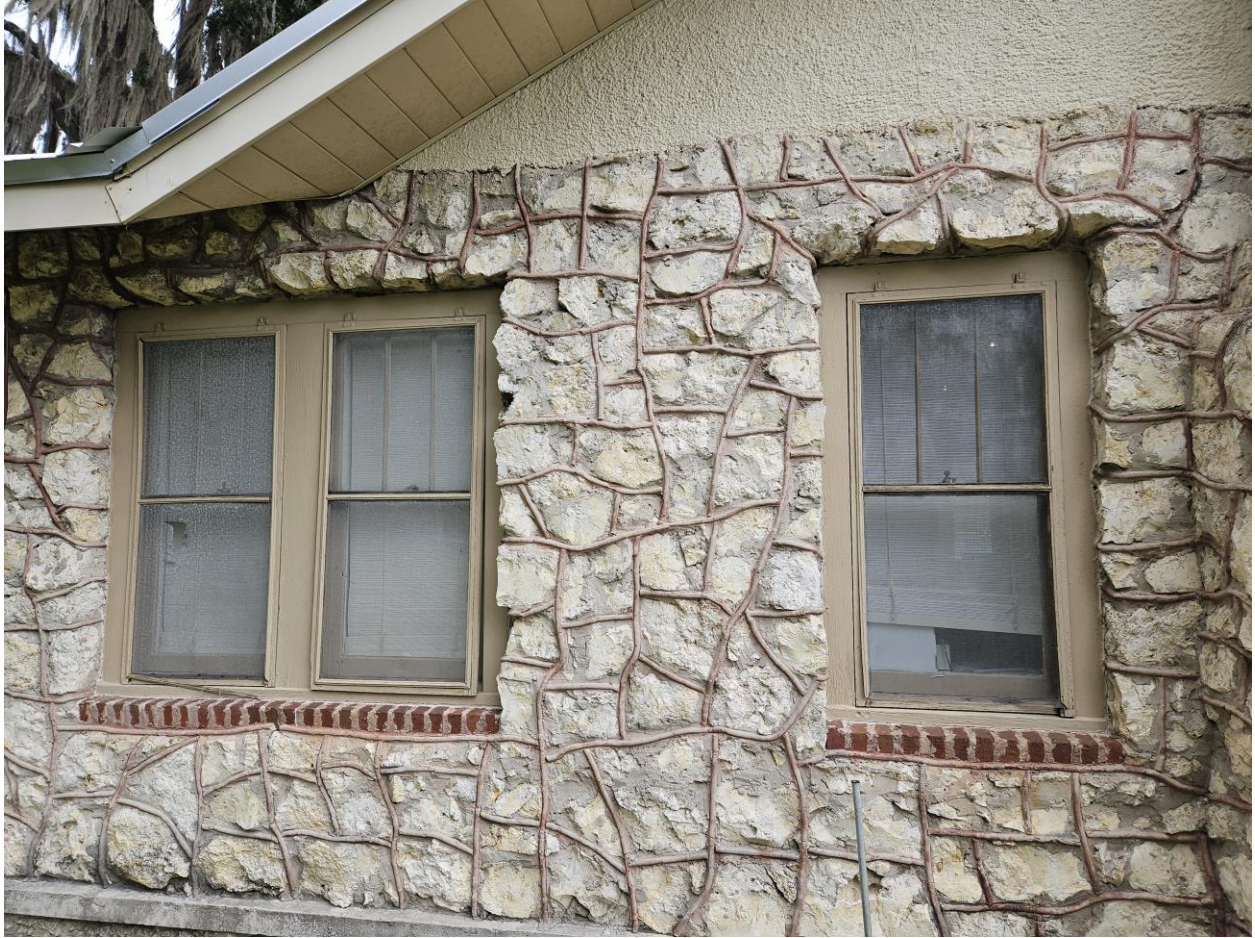
Image 2- Existing conditions – windows.

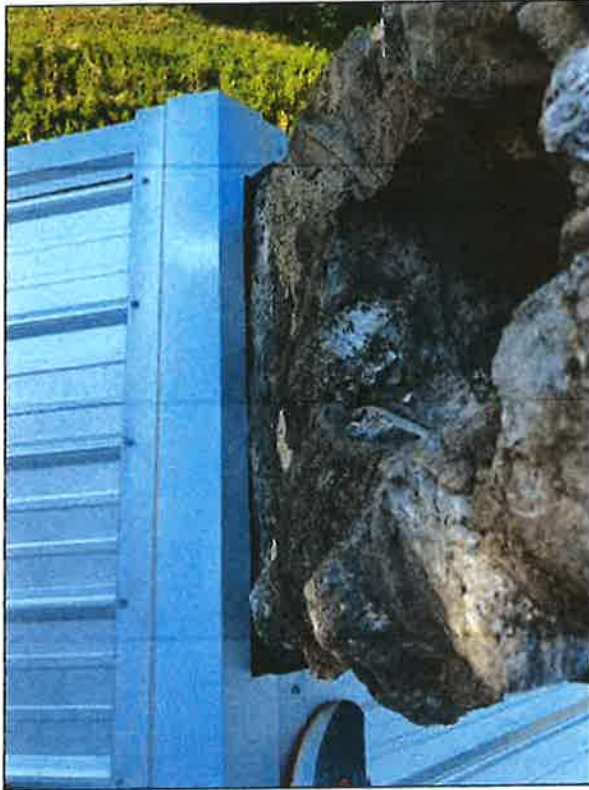
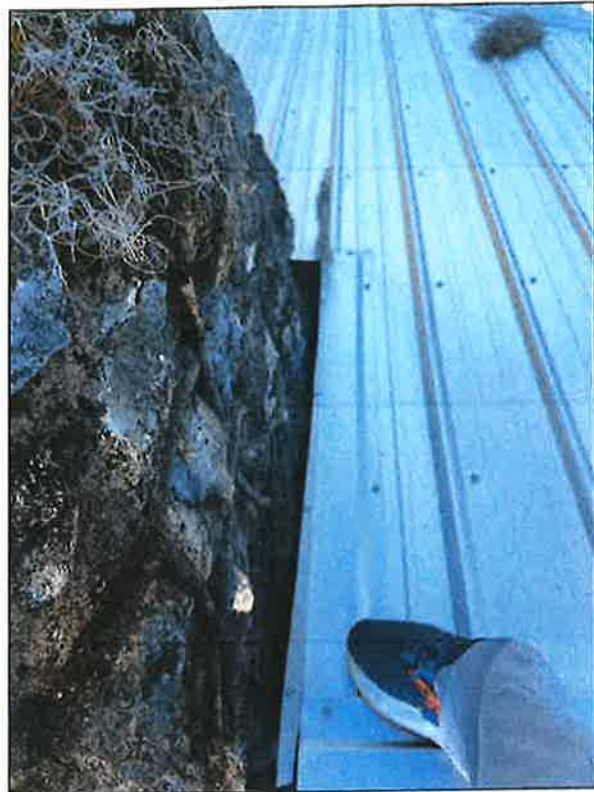
1.2 SKYLIGHTS, CHIMNEYS AND ROOF PENETRATIONS

We recommend adding a screen to cover the chimney flue to prevent critter and pest intrusion, repair or replace by a qualified person is recommended.

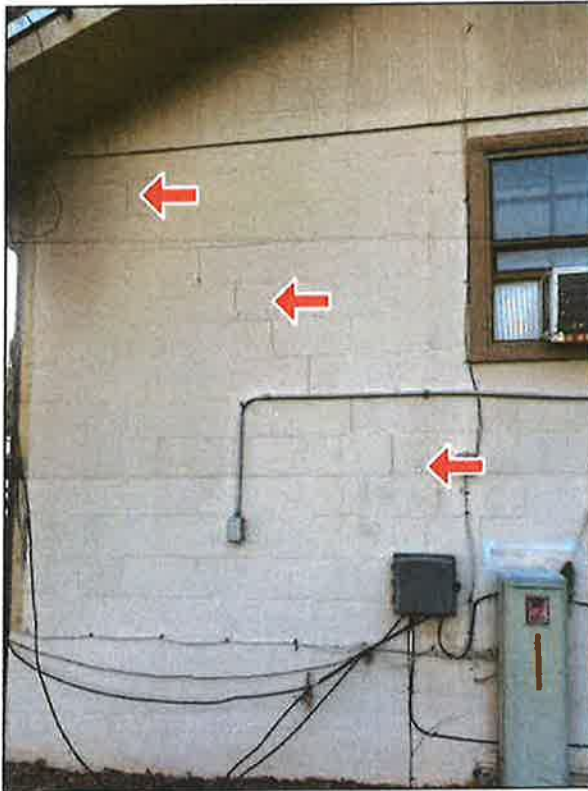
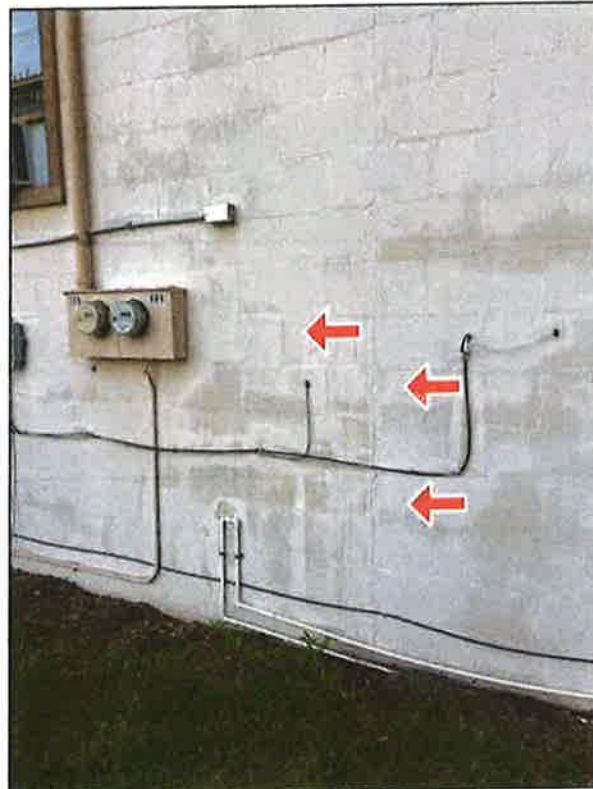
2.1 WALL CLADDING, FLASHING, AND SIDING

(1) We noted multiple areas of cracks in the block and mortar on the addition at the rear of the building as well as in the rock and mortar on the original building, we recommend further review and repair or replace by a qualified person to prevent moisture and pest intrusion. If the cracks grow in size we recommend having a structural engineer inspect the building.

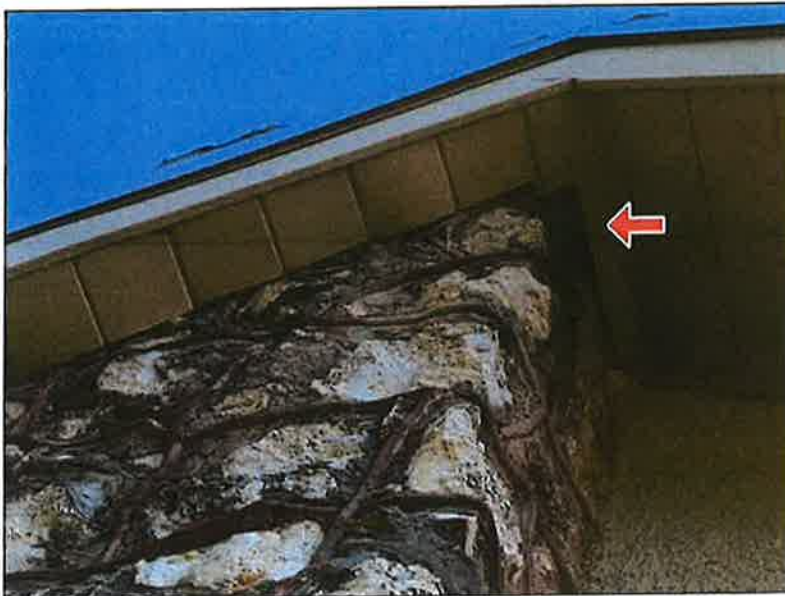
We noted gaps in the soffit at the chimney, we recommend sealing the gaps to prevent pest and critter intrusion.

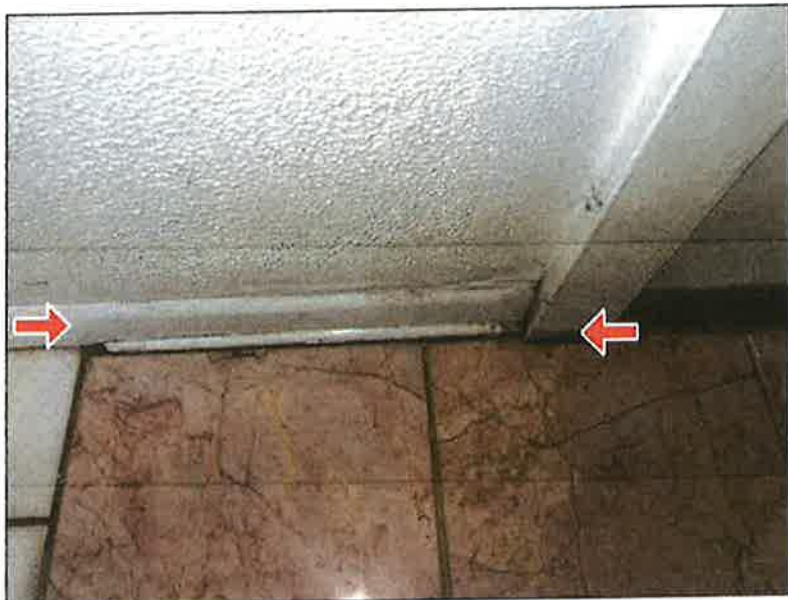
(1) We noted the wall and trim next to the door on the north side of the salon is damaged, we recommend further review and repair or replace by a qualified person.

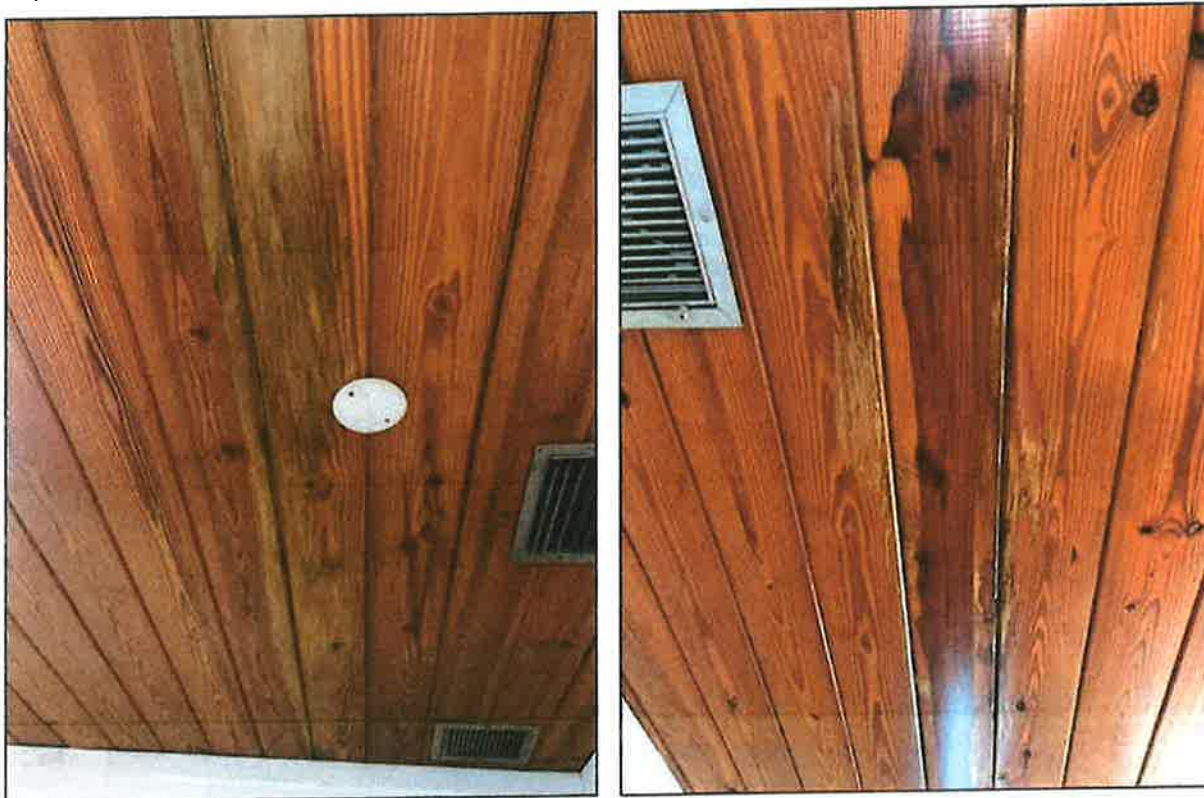
(1) We noted moisture stains on the ceilings in multiple areas, the stains were dry at the time of inspection, the issue causing the stains has been repaired. We recommend repair or replace as needed.

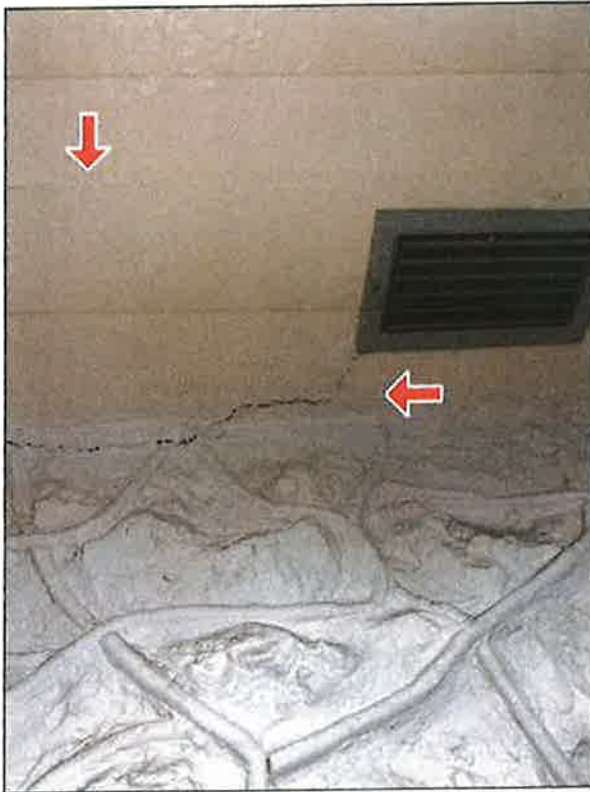
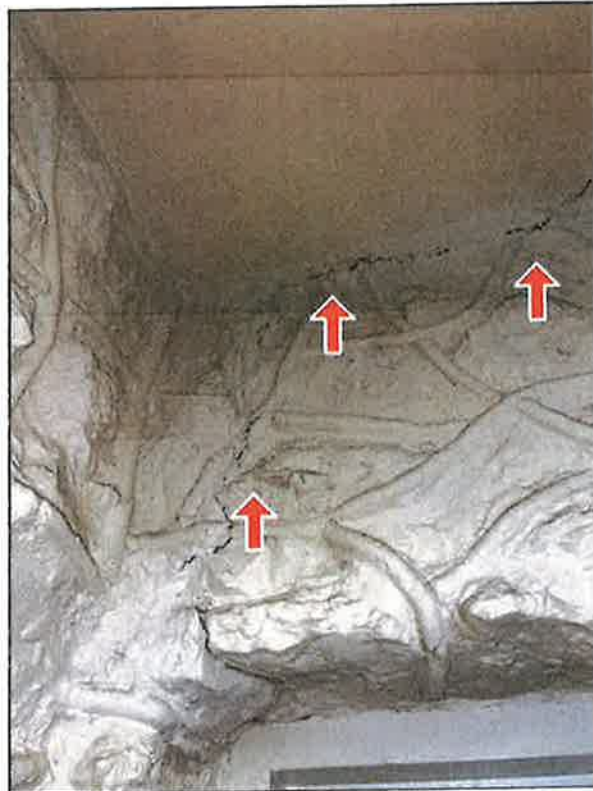
(2) We noted a crack on the ceiling in the front room of the salon, this crack is where the addition was added to the existing building, settlement cracks are common at the joining points. We recommend further review and repair or replace by a qualified person if the crack increases in size.

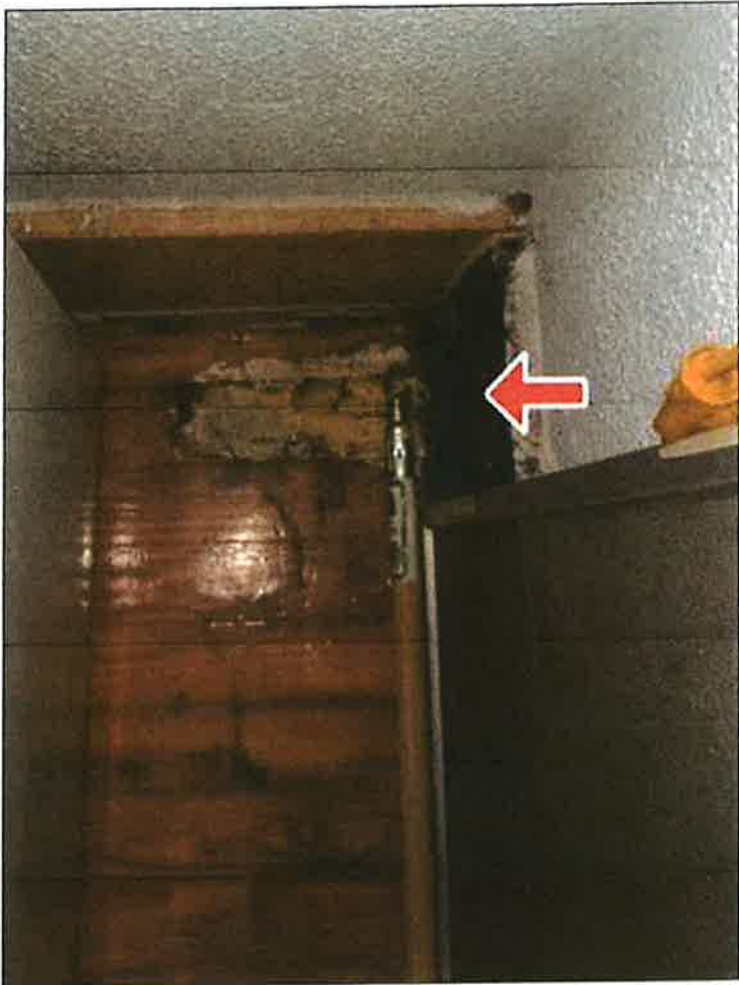
(1) We noted a soft spot in the floor in the right rear room of the Beyond Skin portion of the building, there was moisture damage in the crawlspace under the floor in this area that had wood rot present. We recommend repair or replace by a qualified person.

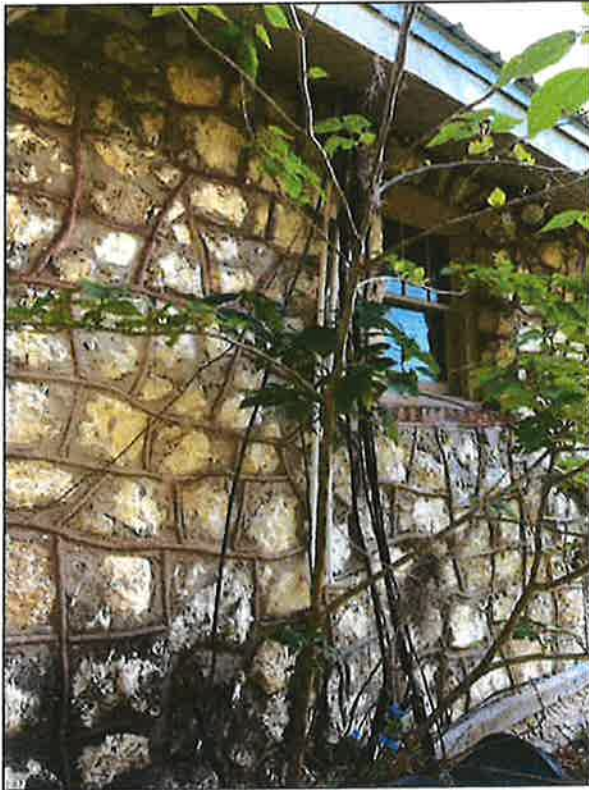
2.0 VEGETATION, GRADING, DRAINAGE, DRIVEWAYS, PATIO FLOOR, WALKWAYS AND RETAINING WALLS (With respect to their effect on the condition of the building)

We recommend keeping all vegetation trimmed back far enough to have access to all areas of the home, keeping the vegetation off of the home will also protect the exterior components. (Siding & mechanicals)

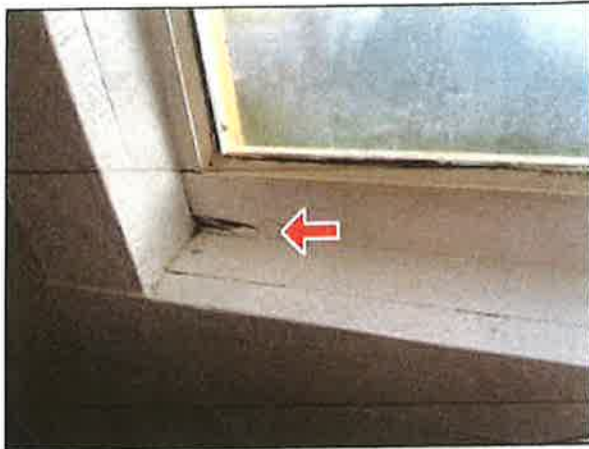
Wood Rot

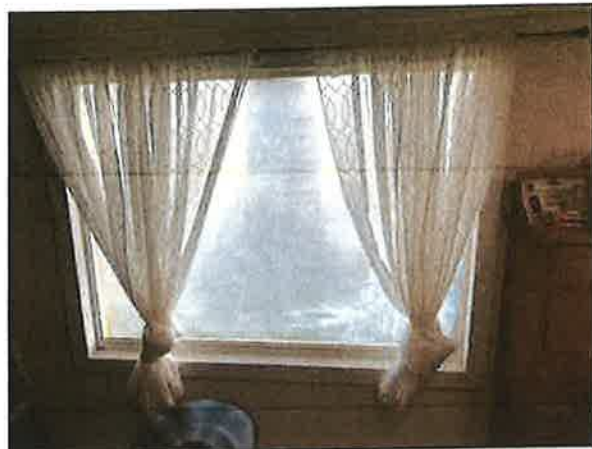
Fogged Glass

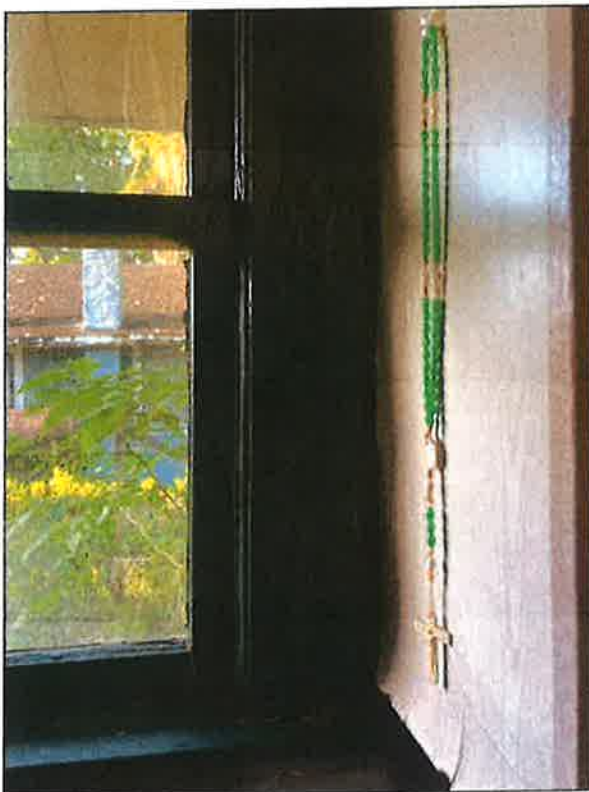
Termite Damage

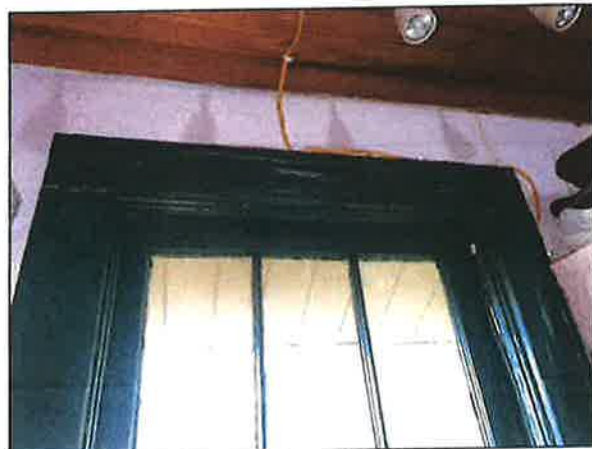
Termite damage.
