## VERTICAL TRANSPORTATION MOD EVALUATION REPORT

December 22, 2025

**OCALA CITY HALL  
110 SOUTHEAST WATULA AVENUE  
OCALA, FL**

VDA No. 79528

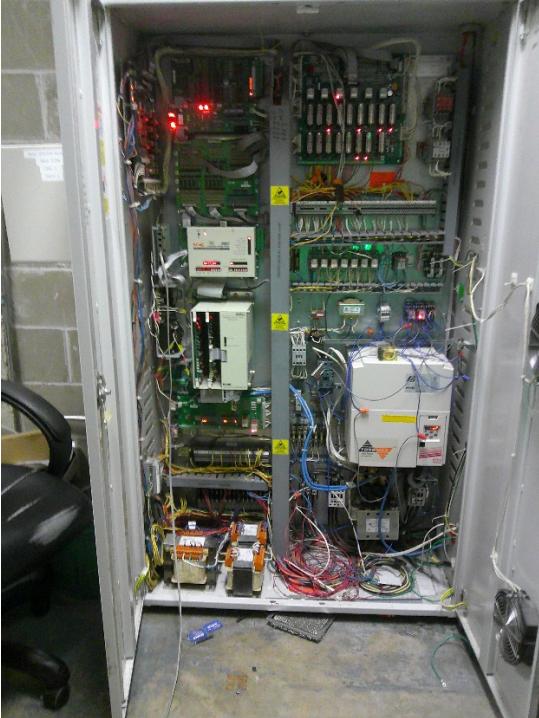
A photograph of an open electrical control cabinet for an elevator. The interior is filled with various electronic components, including a large white KEB TORG MAX 16K PWM AC Drive unit, several green printed circuit boards, and a central processing unit (CPU) with a small screen. Numerous wires and cables are visible, some with red and blue insulation.

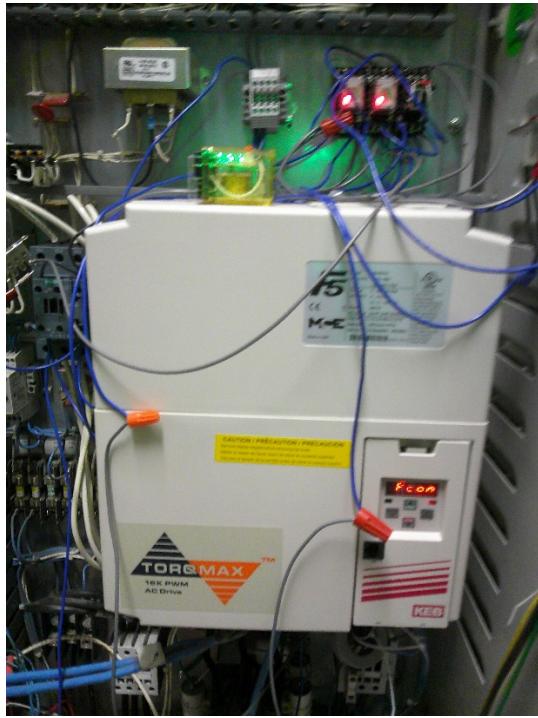
A close-up photograph of the KEB TORG MAX 16K PWM AC Drive unit. The unit is white with a digital display showing "F009" and several physical buttons. It is connected to other electrical components and has a "CAUTION PRECAUTION" label on its side panel.
Elevator Controller installed in 2008	Replaced AC drive wiring that needs to be cleaned up and professional installed. This wiring is NOT acceptable.

- 1. The wiring in the newly installed AC drive is unacceptable. Properly wire up the new drive.**
- 2. Replace the worn cab steadyng plate rubber grommets.**

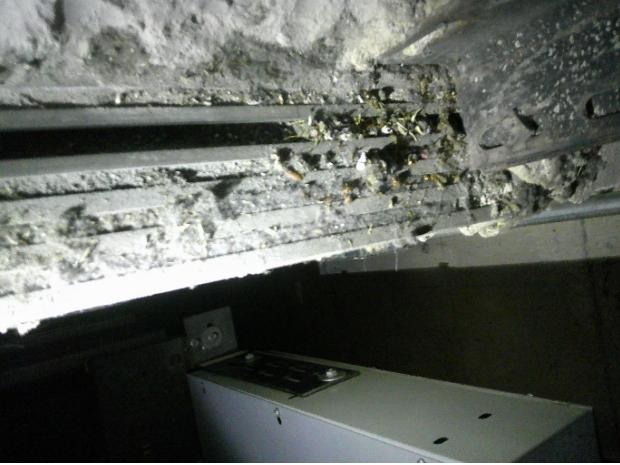
<p>Typical hoistway sill that needs to be cleaned of debris if reliable operation is to be expected.</p>	<p>GAL "MOVFR" door operator that is capable of reliable operation for another 5 years.</p>

3. Adjust the car roller guides to prevent excessive movement “side-to-side” movement of the cab.
4. Thoroughly clean the car and all hoistway sills of all debris.
5. Lubricate the dry hoist ropes.
6. Clean up and organize the spare parts (boards) in the elevator machine room.
