South Elevation

A New Remodel for  
The Hotel Marion

108 North Magnolia Ave,  
Ocala, FL 34475

A201

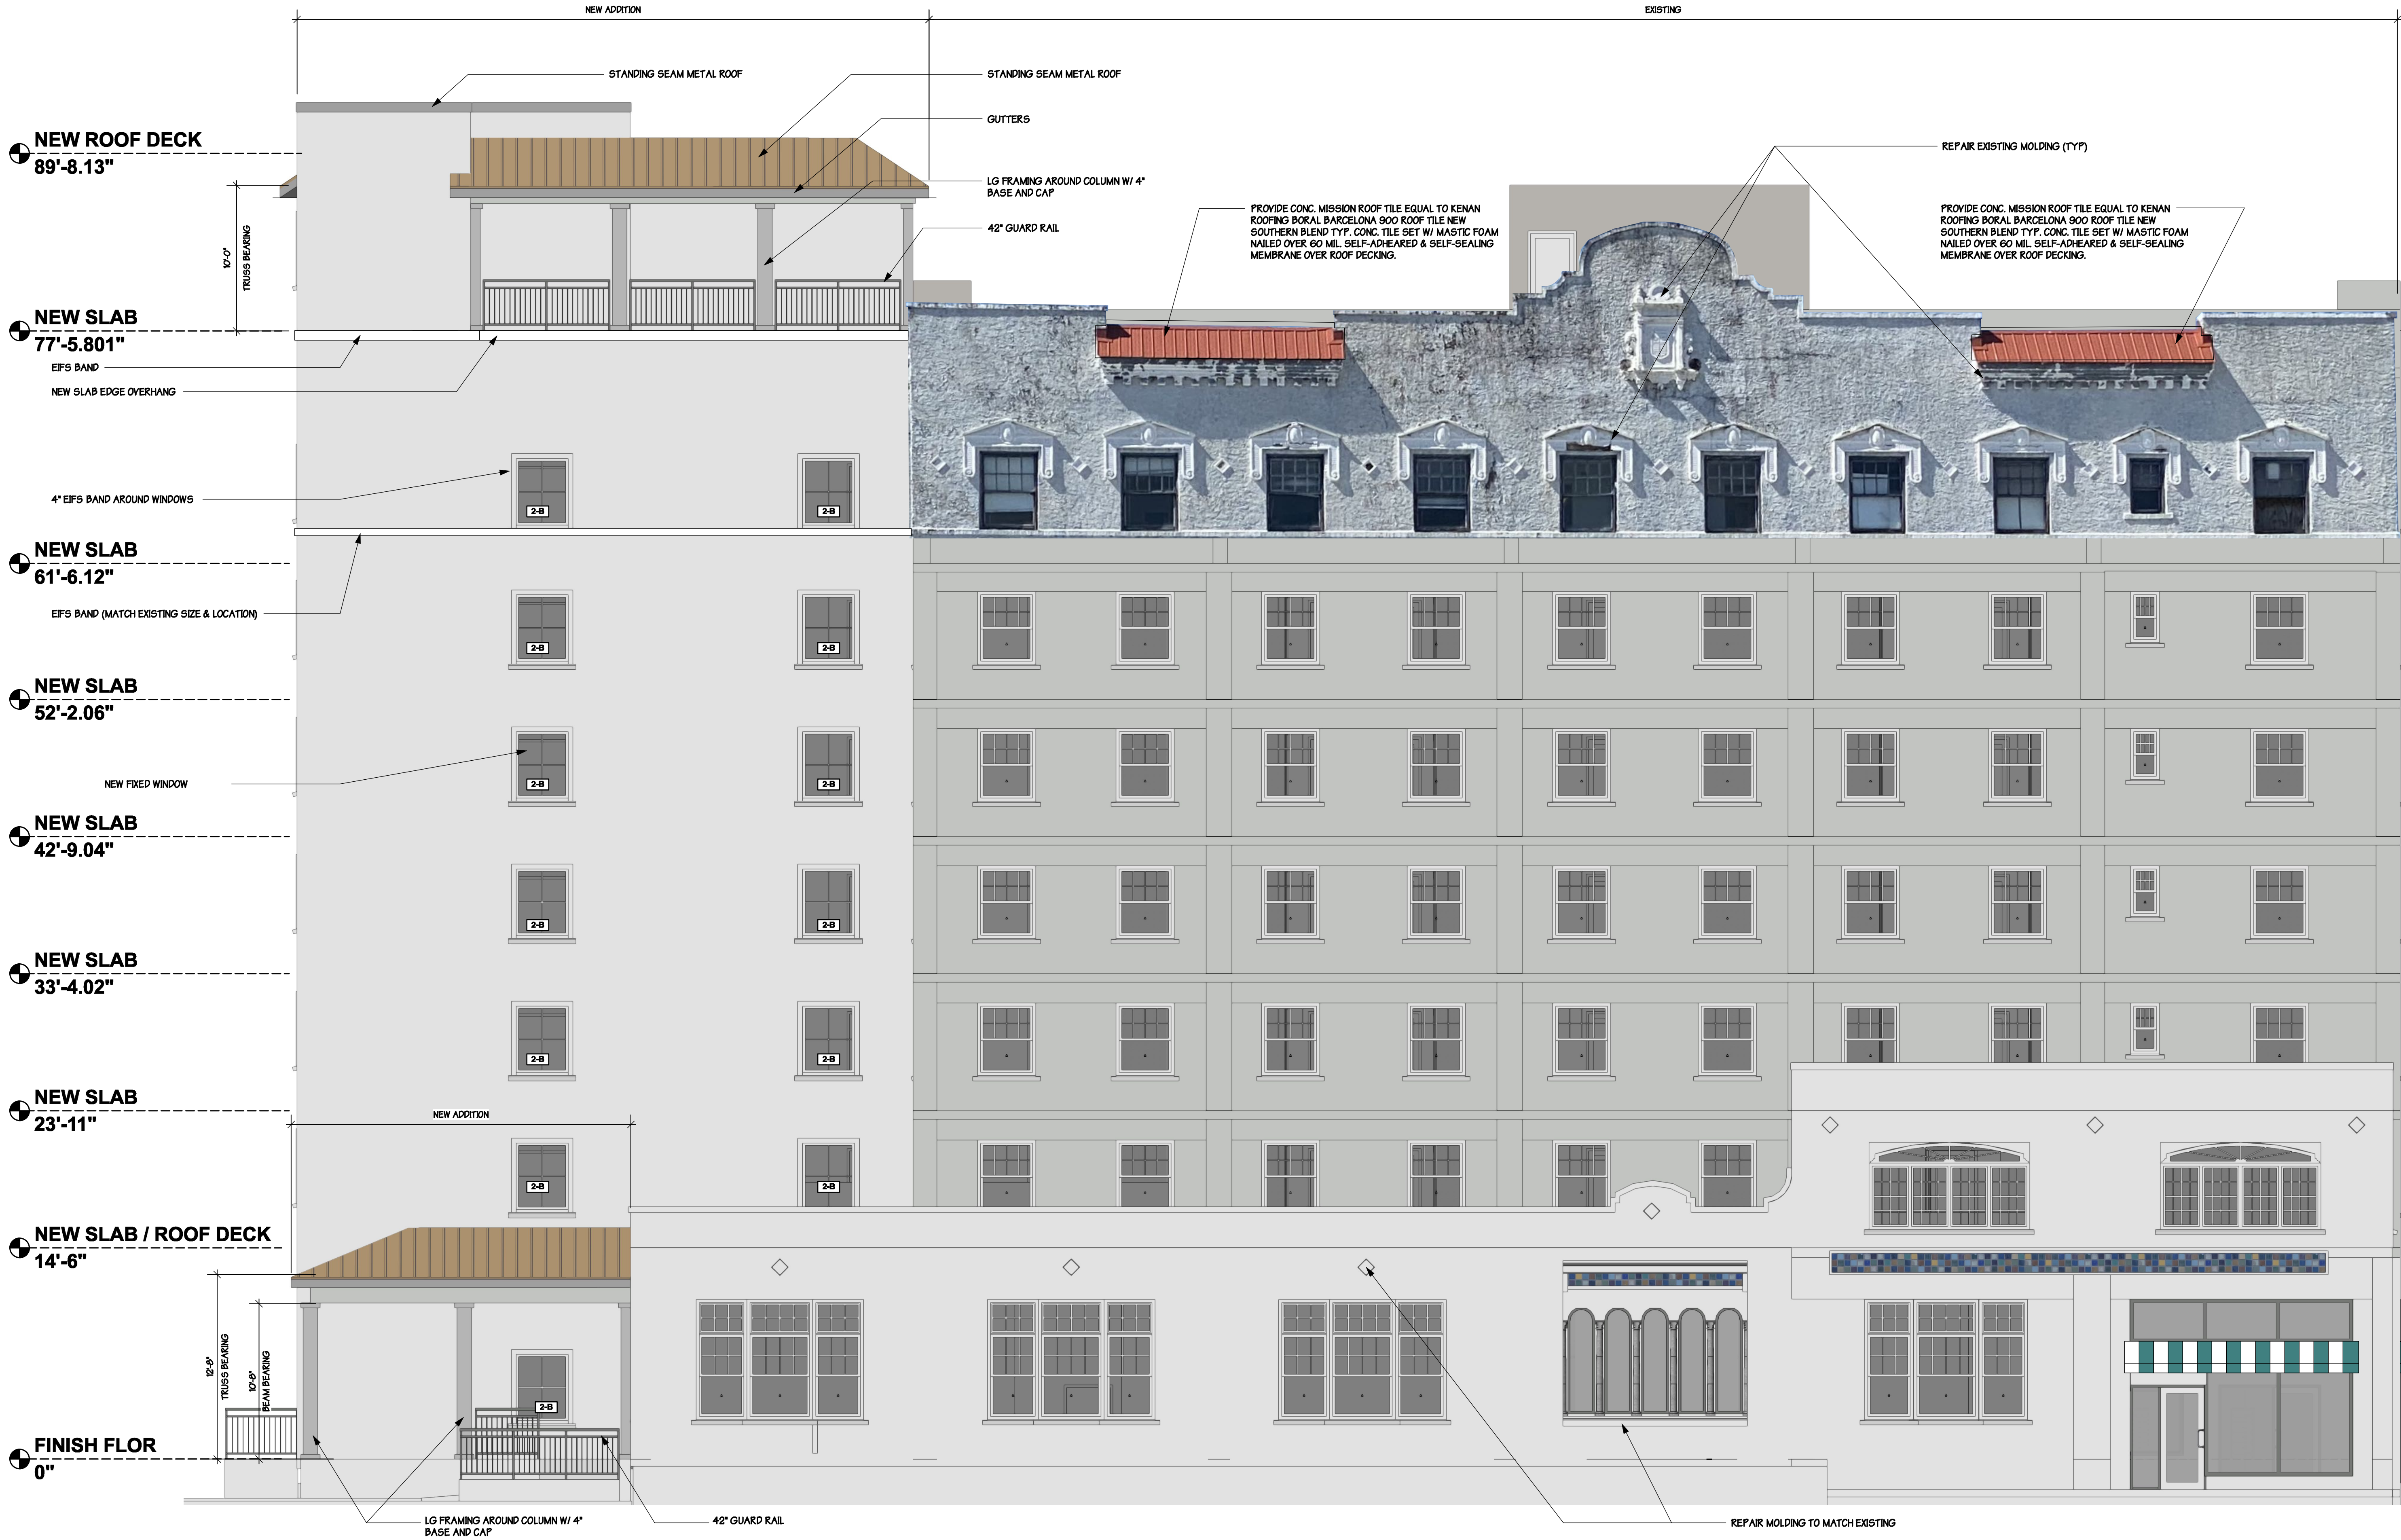
1 SOUTH ELEVATION  
Scale: 3/16" = 1'-0"

- CLEAN, REPAIR AND REPLACE STUCCO AS PER REPAIR INSTRUCTIONS.
- REPAIR EXISTING WINDOWS AND PROVIDE NEW AS INDICATED. PROVIDE A SAMPLE WINDOW FROM EACH MANUFACTURER AND SUBMIT FOR REVIEW. COLOR AND TRIM ACCESSORIES ARE TO MATCH EXISTING.

- DEMO METAL ROOF MATERIAL. REPAIR OR REPLACE SHEATHING. PROVIDE CONC. MISSION ROOF TILE EQUAL TO KENAN ROOFING BORAL BARCELONA 900 ROOF TILE NEW SOUTHERN BLEND TYP. CONC. TILE SET W/ MASTIC FOAM NAILED OVER 60 MIL SELF-ADHEARED & SELF-SEALING MEMBRANE OVER ROOF DECKING.

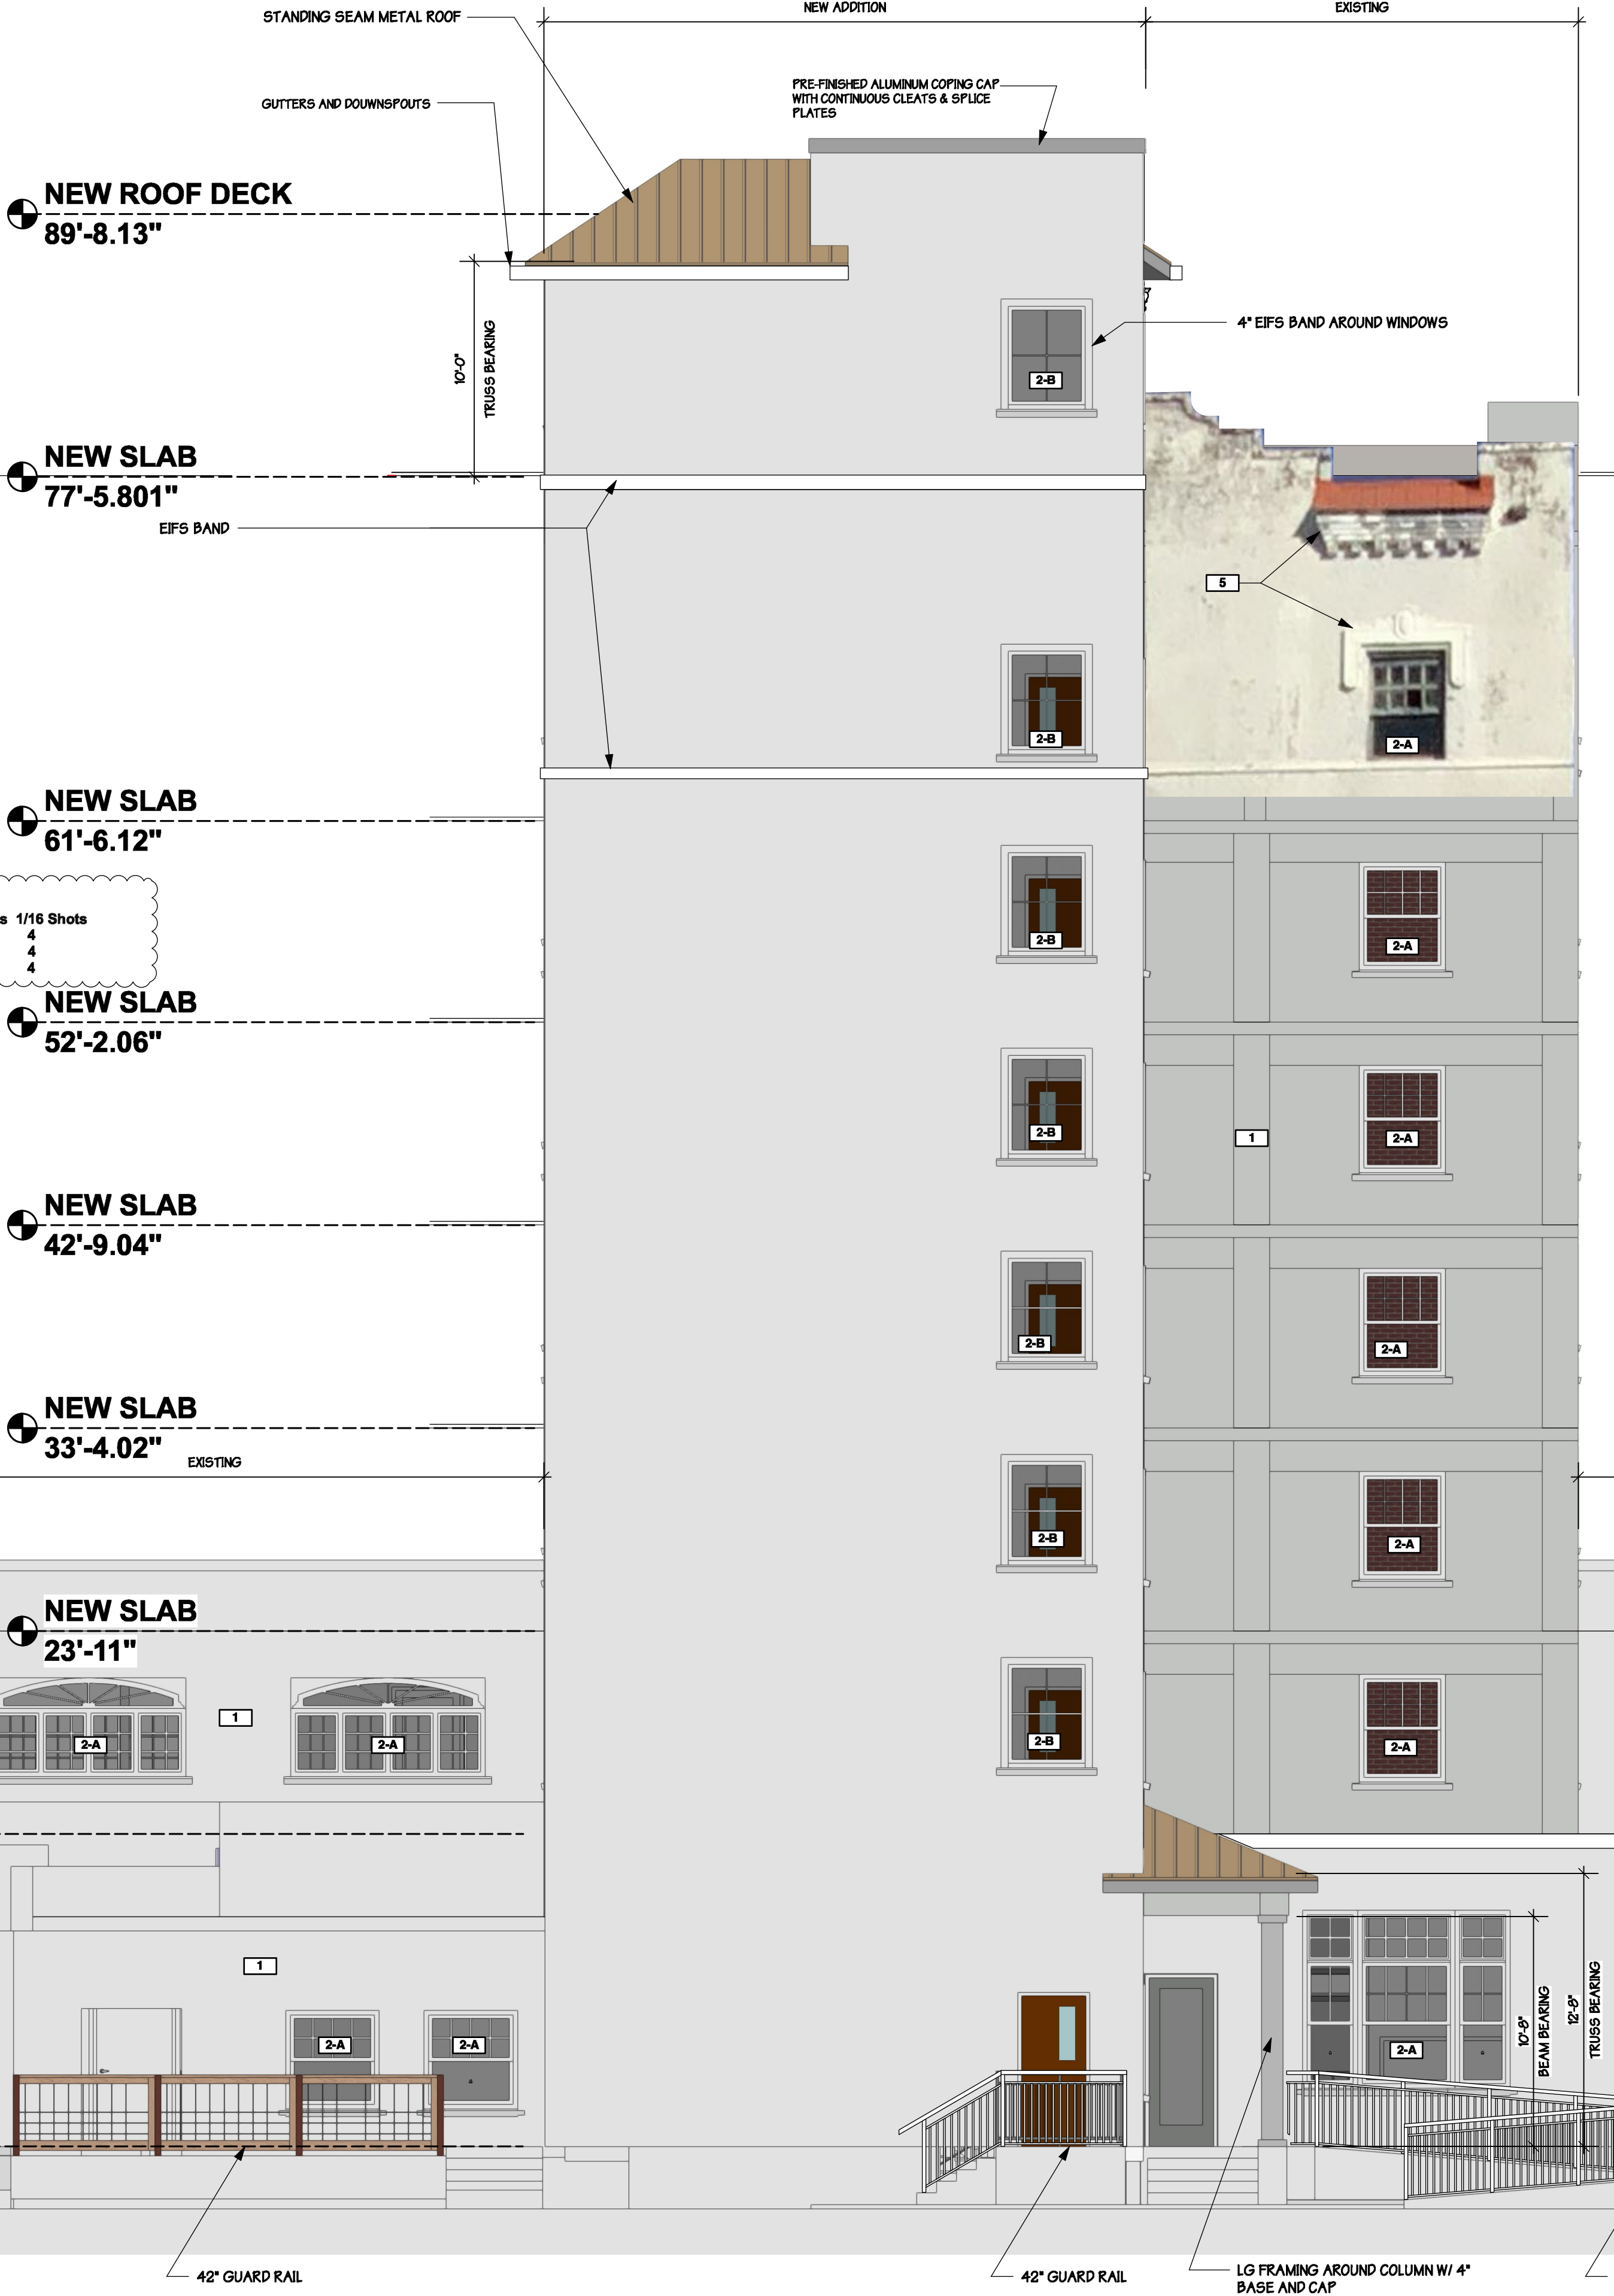
West Elevation  
Scale: 3/16" = 1'-0"

- EXISTING WINDOWS TO REMAIN CLEAN EXISTING METAL FRAMES AND GLASS. RE-SEAL PRIME AND PAINT.
- REMOVE METAL BALCONIES. STRIP METAL OF ALL PAINT, RUST AND COATINGS. ALL RUSTED OR DETERIORATED MATERIAL SHOULD BE REPLACED (TO MATCH EXISTING). ALL METAL SHOULD BE PRIMED AND PAINTED WITH SERIES 66 EPOXY TNEMEC COATING WITH HIGH DISPERSEMENT ACRYLIC FINISH COAT. RE-INSTALL BALCONIES AFTER COMPLETION OF STUCCO REPAIRS.

- EXTERIOR STAIRS:
  - CLEAN AND STRIP ALL PAINT, RUST AND COATINGS TO BARE METAL. ALL CONNECTIONS AND PENETRATIONS SHOULD BE INSPECTED, REPAIRED AND SEALED. ALL RUSTED OR DETERIORATED MATERIAL SHOULD BE REPLACED. ALL METAL SHOULD BE PRIMED AND PAINTED WITH SERIES 66 EPOXY TNEMEC COATING WITH HIGH DISPERSEMENT ACRYLIC FINISH COAT.

West Elevation

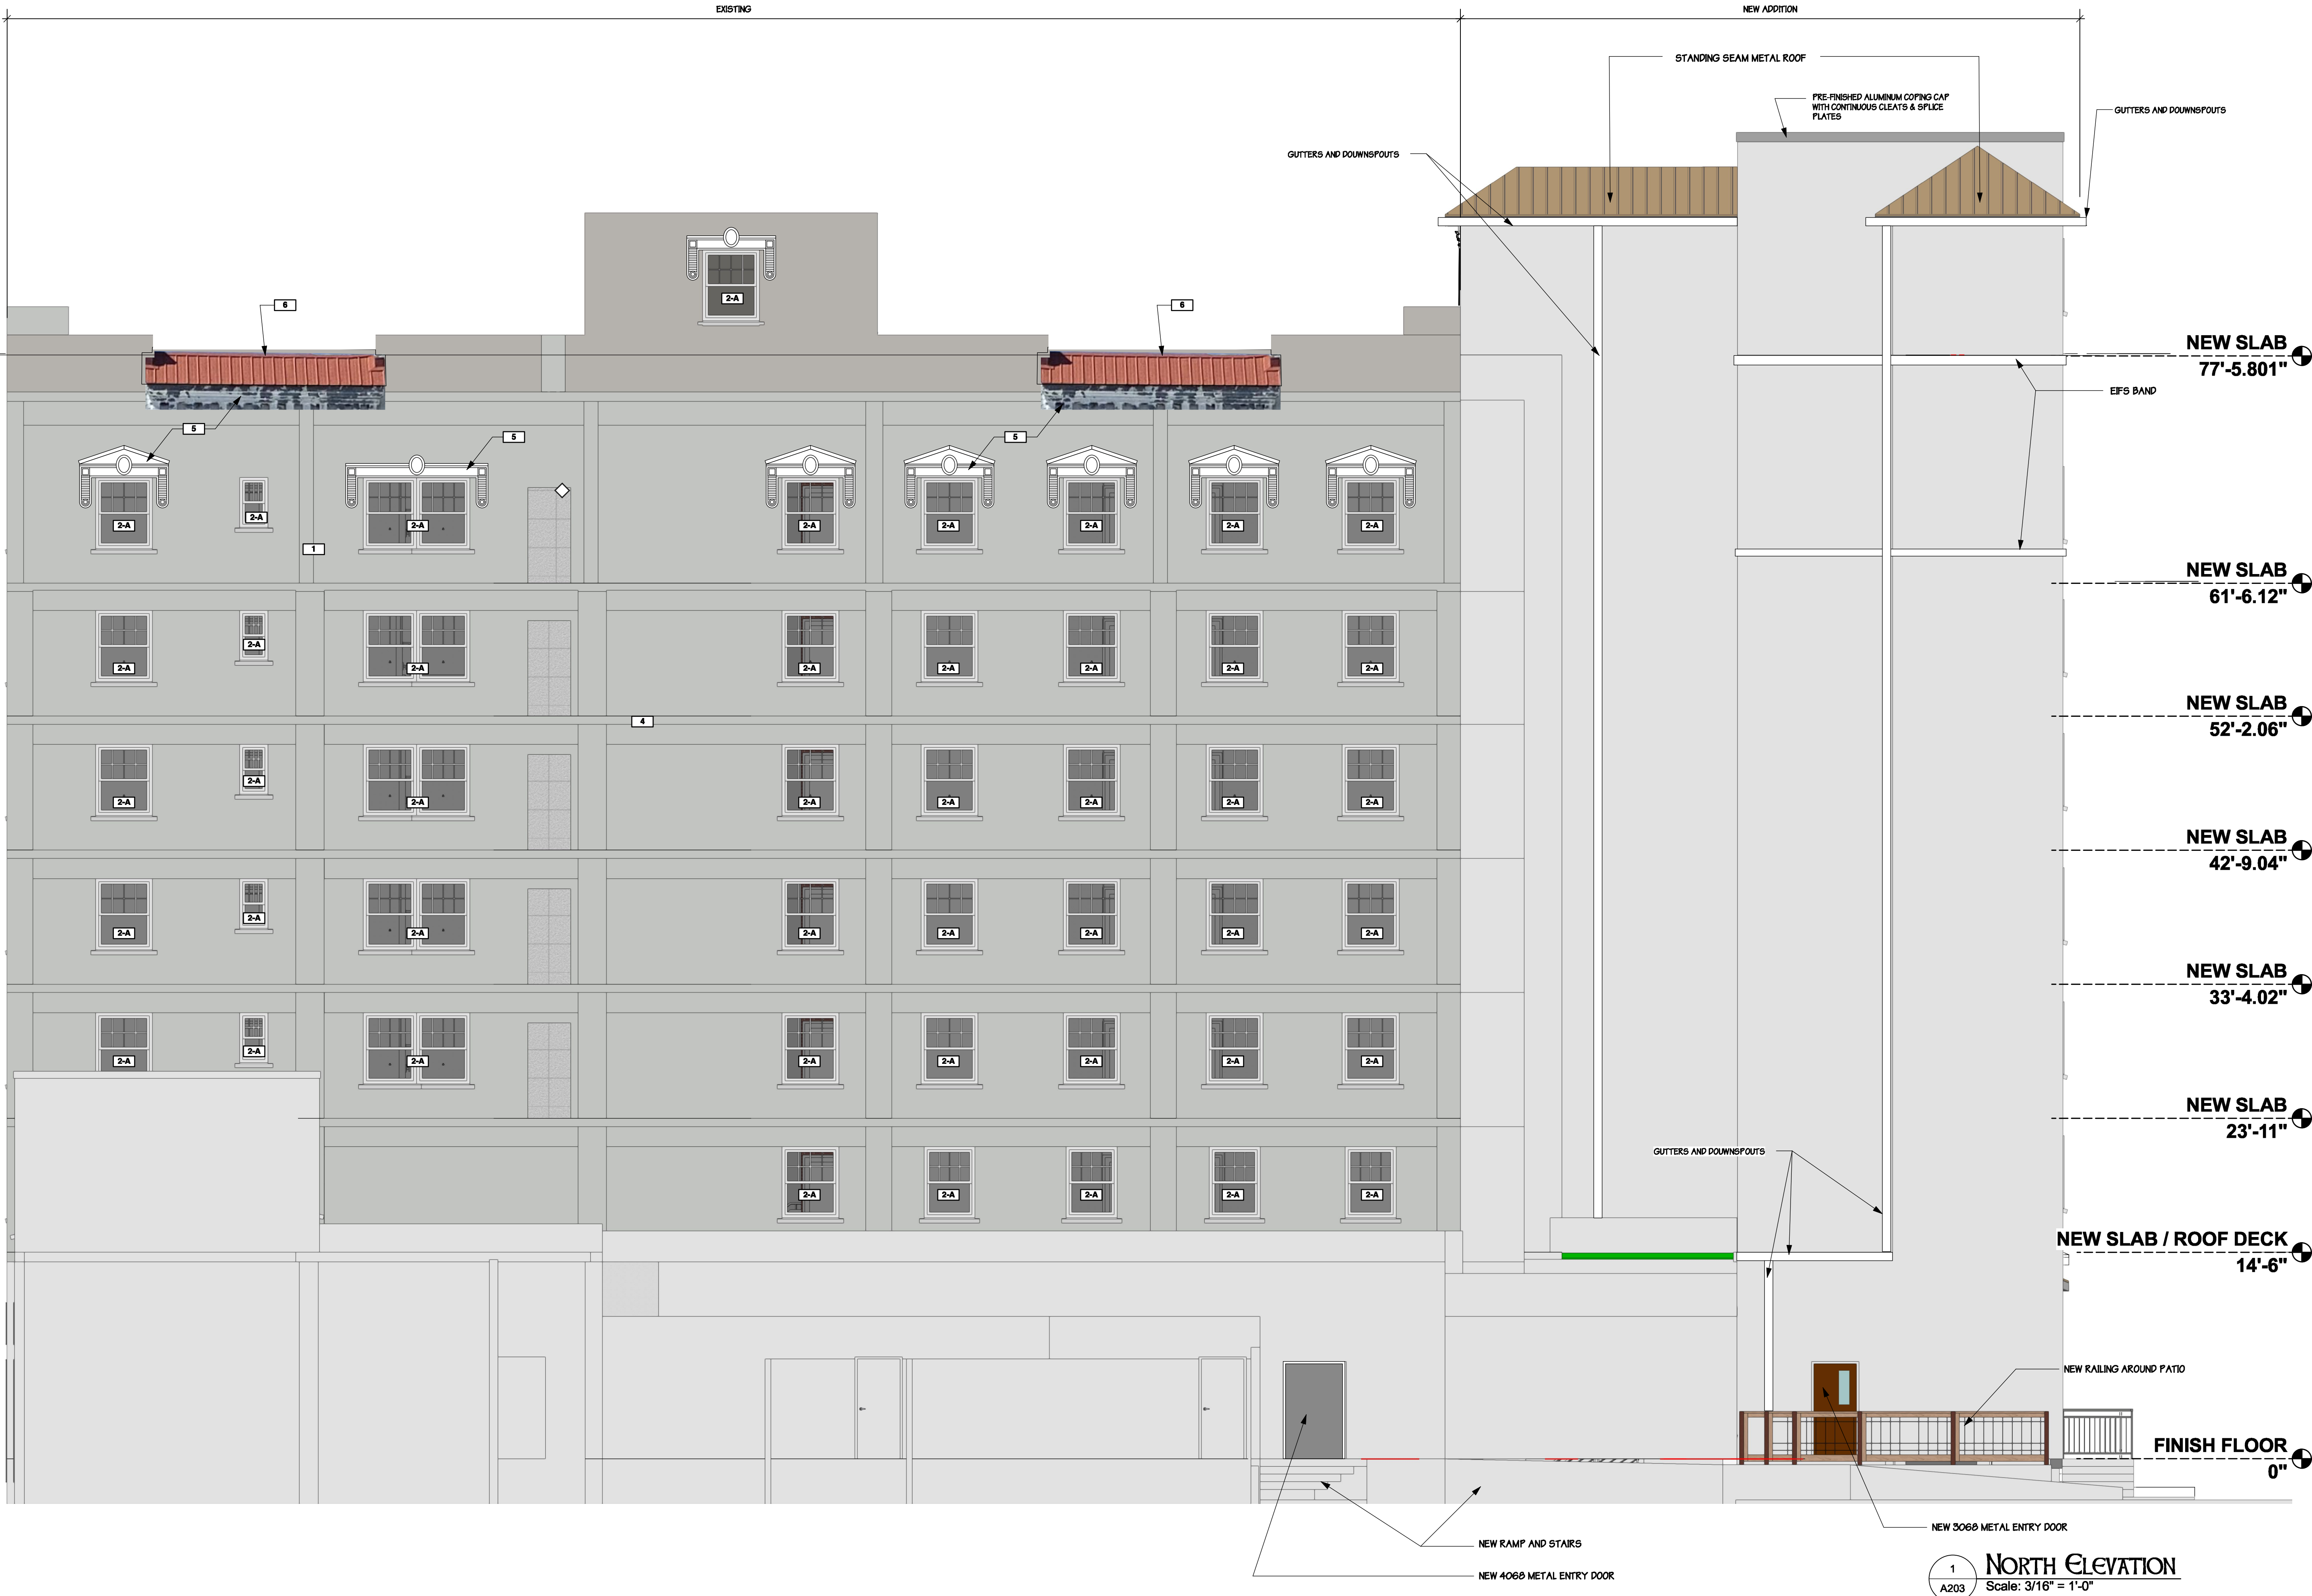
**1 NORTH ELEVATION**  
Scale: 3/16" = 1'-0"

**North Elevation**
