South Elevation

A New Remodel for  
The Hotel Marion

A201

PERMIT / PRICING 90%

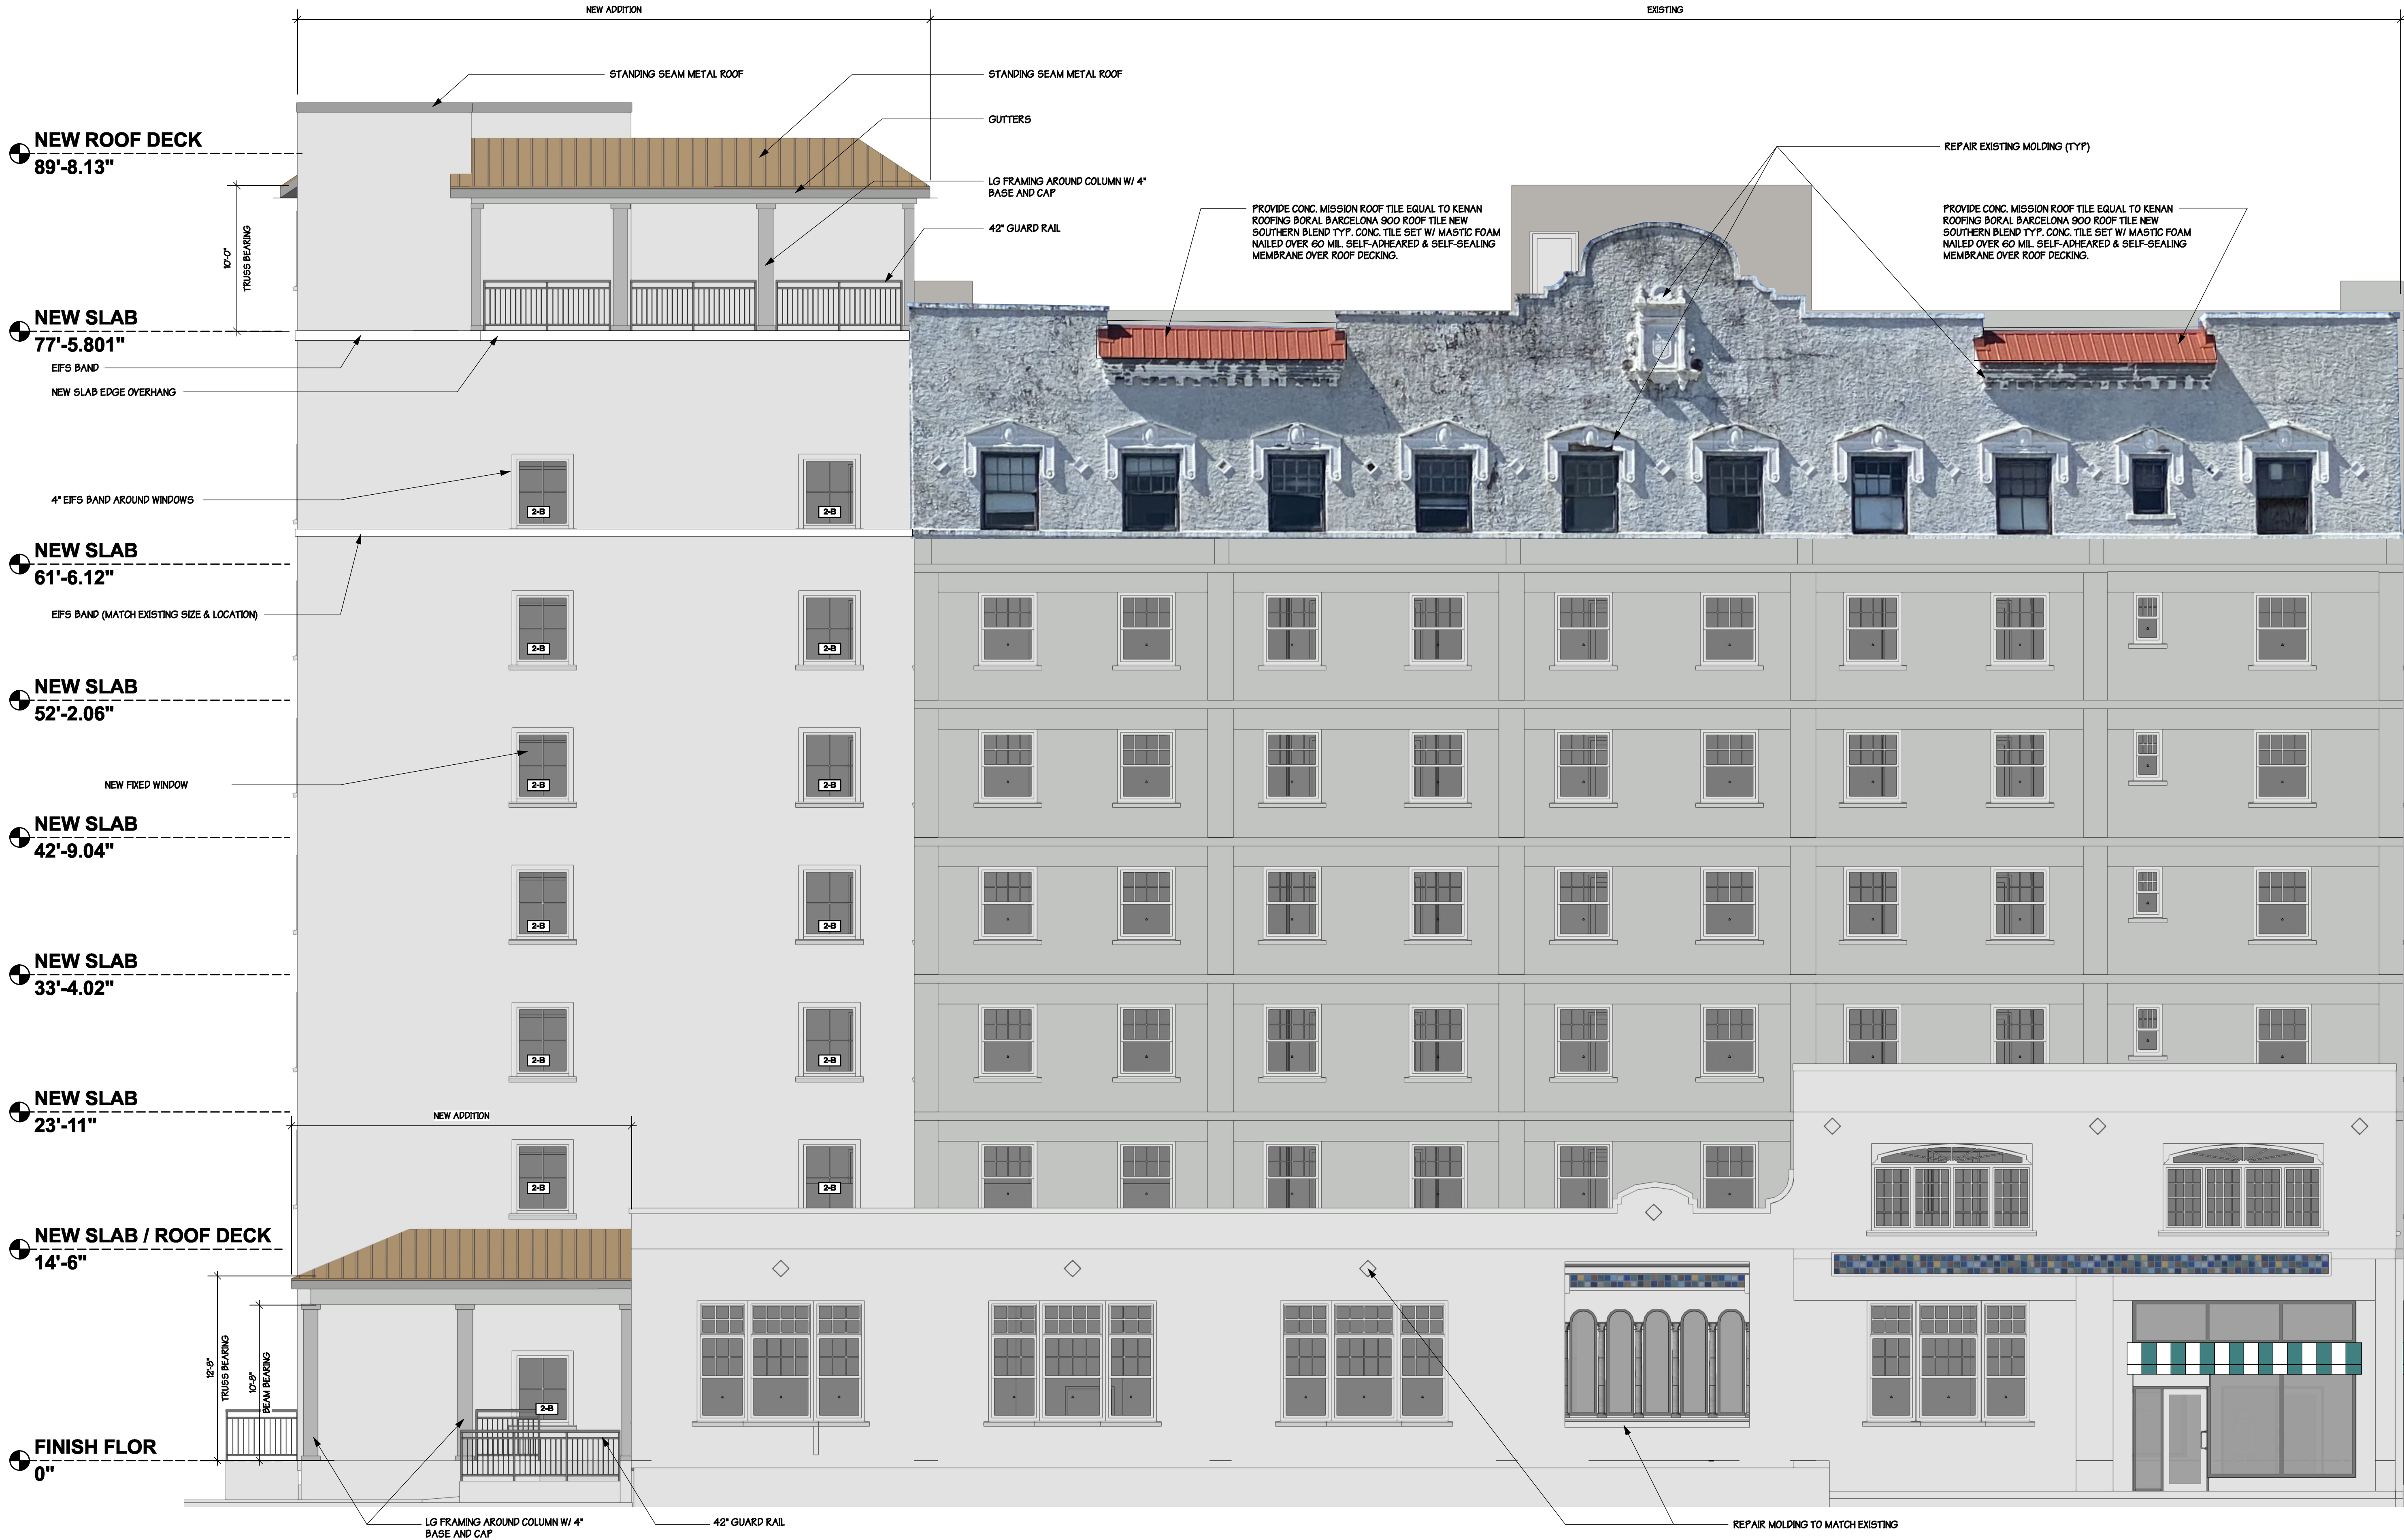
1 SOUTH ELEVATION  
Scale: 3/16" = 1'-0"

ELEVATION NOTES:

- CLEAN, REPAIR AND REPLACE STUCCO AS PER REPAIR INSTRUCTIONS.
- REPAIR EXISTING WINDOWS AND PROVIDE NEW AS INDICATED. PROVIDE A SAMPLE WINDOW FROM EACH MANUFACTURER AND SUBMIT FOR REVIEW. COLOR AND TRIM ACCESSORIES ARE TO MATCH EXISTING.

- REPAIR AND RE-PAINT EXISTING WINDOWS.
  - ACCOYA WOOD WINDOWS (BY AUSTIN HISTORICAL) WITH EXPOSED MUNTIN GRID TO MATCH EXISTING DESIGN. FLORIDA PRODUCT APPROVALS BY DELEGATED ENGINEER THROUGH AUSTIN HISTORICAL.

- EXISTING WINDOWS TO REMAIN CLEAN EXISTING METAL FRAMES AND GLASS. RE-SEAL, PRIME AND PAINT.
- REMOVE METAL BALCONIES. STRIP METAL OF ALL PAINT, RUST AND COATINGS. ALL RUSTED OR DETERIORATED MATERIAL SHOULD BE REPLACED (TO MATCH EXISTING). ALL METAL SHOULD BE PRIMED AND PAINTED WITH SERIES 66 EPOXY TNEMEC COATING WITH HIGH DISPERSEMENT ACRYLIC FINISH COAT. RE-INSTALL BALCONIES AFTER COMPLETION OF STUCCO REPAIRS.

- EXTERIOR STAIRS:
  - CLEAN AND STRIP ALL PAINT, RUST AND COATINGS TO BARE METAL. ALL CONNECTIONS AND PENETRATIONS SHOULD BE INSPECTED, REPAIRED AND SEALED. ALL RUSTED OR DETERIORATED MATERIAL SHOULD BE REPLACED. ALL METAL SHOULD BE PRIMED AND PAINTED WITH SERIES 66 EPOXY TNEMEC COATING WITH HIGH DISPERSEMENT ACRYLIC FINISH COAT.

- CLEAN, REPAIR OR REPLACE ALL DAMAGED CAST TRIM TO MATCH EXISTING BASED ON U.S. DEPARTMENT OF THE INTERIOR NATIONAL PARK SERVICE RECOMMENDATION FOR REPAIR AND REPLACEMENT OF HISTORIC CAST STONE - PRESERVATION BRIEF #42

- DEMO METAL ROOF MATERIAL. REPAIR OR REPLACE SHEATHING. PROVIDE CONC. MISSION ROOF TILE EQUAL TO KENAN ROOFING BORAL BARCELONA 900 ROOF TILE NEW SOUTHERN BLEND TYP. CONC. TILE SET W/ MASTIC FOAM NAILED OVER 60 MIL SELF-ADHEARED & SELF-SEALING MEMBRANE OVER ROOF DECKING.

- PROVIDE NEW AWNINGS AND FRAMES. COORDINATE COLOR SELECTION WITH OWNER.
- DEMO UNUSED COMMUNICATIONS EQUIPMENT AND PATCH ALL PENETRATIONS. COORDINATE WITH OWNER.

STUCCO REPAIR PROCEDURE:

- PRESSURE WASH THE ENTIRE EXTERIOR TO REMOVE THE EXISTING COATING AND DELAMINATED STUCCO.
- SOUNDING OF THE EXISTING STUCCO WALLS IS NEEDED ON THE ENTIRE EXTERIOR TO DETERMINE BONDING AND EXTENT OF WORK NEEDED.

- PROVIDE AN ALLOWANCE CONSIDERING THE UNIT PRICING (\$/S.F.) FOR THE REPAIRS NEEDED.
- CONFIRM ALL AREAS THAT ARE STILL BONDED TO THE CONCRETE SUBSTRATE OR CLAY TILE (TERRA COTTA UNITS) UNITS SUBSTRATE TO ENSURE THEY ARE WELL BONDED.

- CLEAN AND SQUARE OFF ALL EDGES OF WELL BONDED STUCCO ADJACENT TO DELAMINATED STUCCO.
- GRIND THE STUCCO SURFACE TO FLATTEN THE EXISTING STUCCO TEXTURE AND EXPOSE AS MUCH OF THE MASONRY SURFACE AS REASONABLY POSSIBLE.

- PROVIDE MOCKUPS FOR BONDING, MATERIAL MIX, COATINGS, SEALANTS, ETC. ADHESION OF THE STUCCO DIRECTLY TO THE CONCRETE SUBSTRATE CAN BE CONFIRMED BUT ONLY AFTER FULL CURING OF THE STUCCO OVER TIME. HISTORIC TYPE STUCCO WITH PORTLAND CEMENT SHOULD DAMP CURE AS LONG AS POSSIBLE BUT NO LESS THAN 14 DAYS.

- NEW TEXTURE TO MATCH APPROVED MOCKUP.
- REPAIR AND REBUILD ALL AREAS OF DELAMINATED STUCCO WITH HISTORIC STUCCO MIX TO MATCH AS CLOSE AS POSSIBLE TO THE ORIGINAL WITH THE USE OF PORTLAND CEMENT, SAND, WATER, AND LIME. CRITICAL MIX PROPORTIONS SHOULD BE EVALUATED BASED ON EXISTING STUCCO STRENGTH. NEW STUCCO TO MATCH SHOULD BE EQUAL TO OR LESS THAN THE ORIGINAL MIX WHEN POSSIBLE. INSTALLER MUST BE EXPERIENCED IN THIS WORKUP AND MUST INSTALL MOCKUPS IN A 4' X 4' APPLICATION. THE NEW STUCCO SHOULD DUPLICATE THE OLD AS CLOSELY AS POSSIBLE IN STRENGTH, COMPOSITION, COLOR, AND TEXTURE. ONE EXAMPLE FOR A MIX IS AS FOLLOWS:

- AMERICAN PORTLAND CEMENT STUCCO SPECIFICATIONS ( C. 1929)
  - BASE COATS:
    - 5 POUNDS, DRY, HYDRATED LIME
    - 1 BAG PORTLAND CEMENT (94 LBS.)
    - NOT LESS THAN 3 CUBIC FEET (3 BAGS) SAND (PASSED THROUGH A #8 SCREEN)

- WATER TO MAKE A WORKABLE MIX.
  - FINISH COAT:
    - USE WHITE PORTLAND CEMENT IN THE MIX IN THE SAME PROPORTIONS AS ABOVE.
    - TO COLOR THE STUCCO ADD NOT MORE THAN 10 POUNDS PIGMENT FOR EACH BAG OF CEMENT CONTAINED IN THE MIX.

- ALL AREAS OF STUCCO REPAIR SHOULD PROPERLY DAMP CURE A MINIMUM OF 14 DAYS BEFORE INSTALLATION OF A EXTERIOR COATING SYSTEM. ALL STUCCO REMAINING SHOULD BE CLEANED AND PREPARED FOR COATING APPLICATION WHEN THE ENTIRE WALL IS COATED.
